Panther Fire Dozer Accident and Motor Grader Rollover

Lessons Shared

<i>Date:</i>	9/12/2017	<i>Temperature:</i>	94°
<i>Location:</i>	King County, Texas	<i>RH:</i>	24%
<i>Fuel Type:</i>	Grass/Brush	<i>Wind:</i>	NE 6 mph, G 12 mph
<i>Topography:</i>	Steep, Broken Terrain	<i>Fire Behavior:</i>	Moderate
<i>Soil Type:</i>	Deep Sand	<i>Complexity:</i>	Type 4

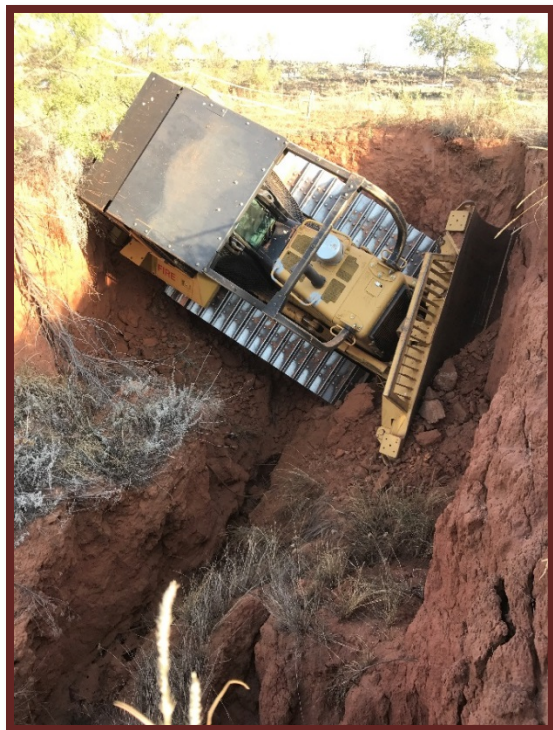
Looking up-drainage toward motor grader line

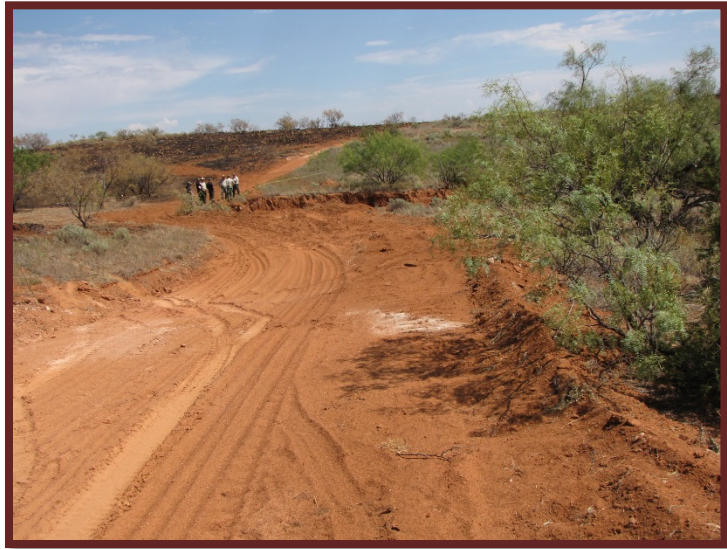
At 2040, Dozer 1 lost sight of Swamper 1 in the heavy dust and stopped the dozer. During that time, Swamper 1 followed the motor grader line around a slight curve that went around a ravine on the green side of the line. Tall grass and lack of visibility concealed the ravine, so it was not noticed by Swamper 1 or Dozer 1. Swamper 1 was wearing a flashing, red safety light on the back of his pack, which helped Dozer 1 see him through the thick dust. When Dozer 1 regained visibility, Swamper 1 was walking on the motor grader line directly in front of the dozer, but on the other side of the ravine. Dozer 1 then continued forward, following Swamper 1. The dozer tracked directly into the ravine and slid down, coming to a stop in the head of the ravine.

Looking down motor grader line, showing bend in the line around ravine (post dozer removal)

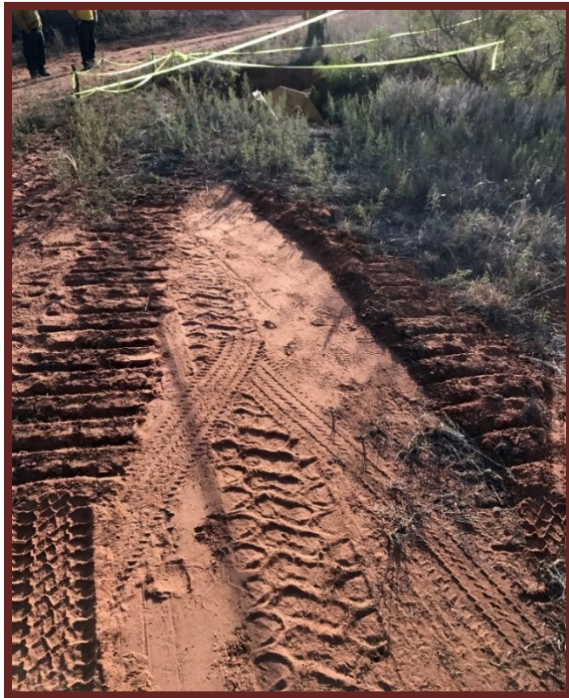
Looking down grader line with dozer in ravine

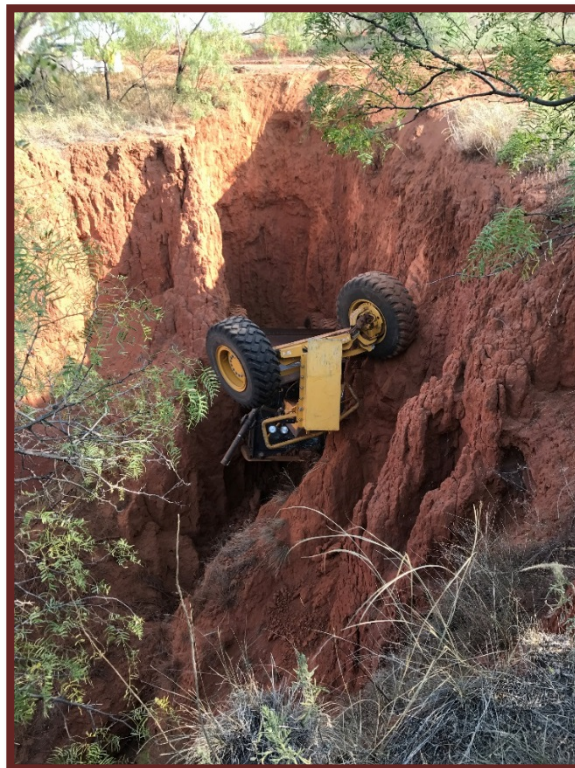
concealed a deep ravine next to the line. The motor grader was unknowingly driving along the edge of the ravine when the rear tires slipped, dragging the entire machine down and flipping it upside down as it fell to bottom of the ravine.

Motor grader in ravine, looking up-drainage

Following the accidents, both operators admitted to not wearing a seat belt that night. Both operators also stressed that in the future they will always wear a seatbelt while operating any equipment. *“If it had kept going (rolled) not having my seat belt on, I would have been dead”*

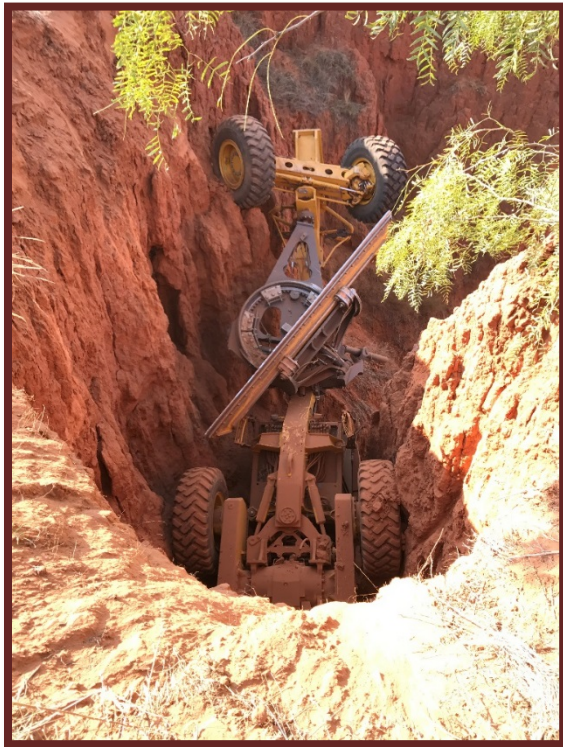
Motor grader in ravine, looking down from grader line
