Freestone County UTV Rollover

Lessons Shared

On March 14, 2018, Texas A&M Forest Service (TFS) resources were requested to the County Road 241 Fire in Freestone County, Texas. While performing fire suppression operations, a Utility Terrain Vehicle (UTV) with one firefighter rolled over resulting in minor injuries and minor damage to the equipment.

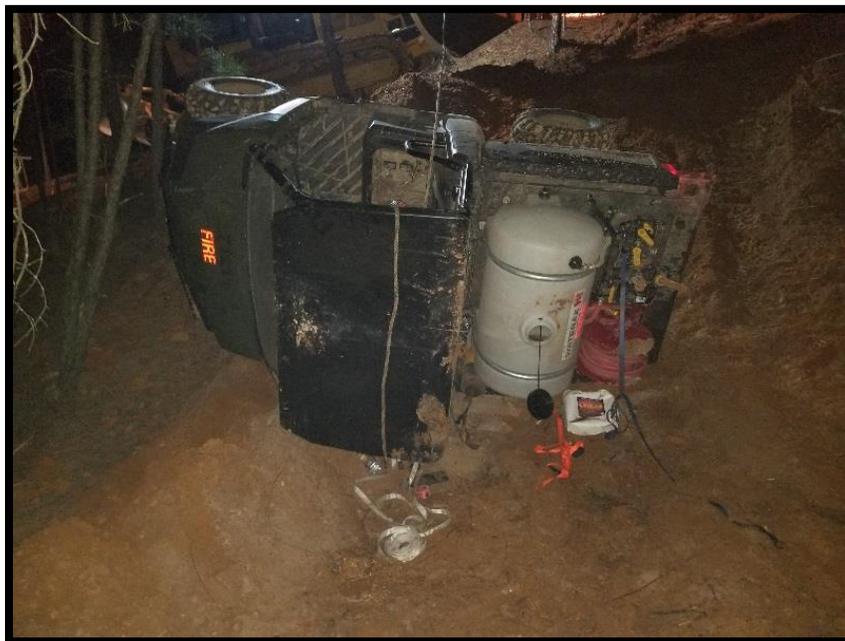
The UTV after being winched onto its driver side with dozer in the background to finish winching upright.

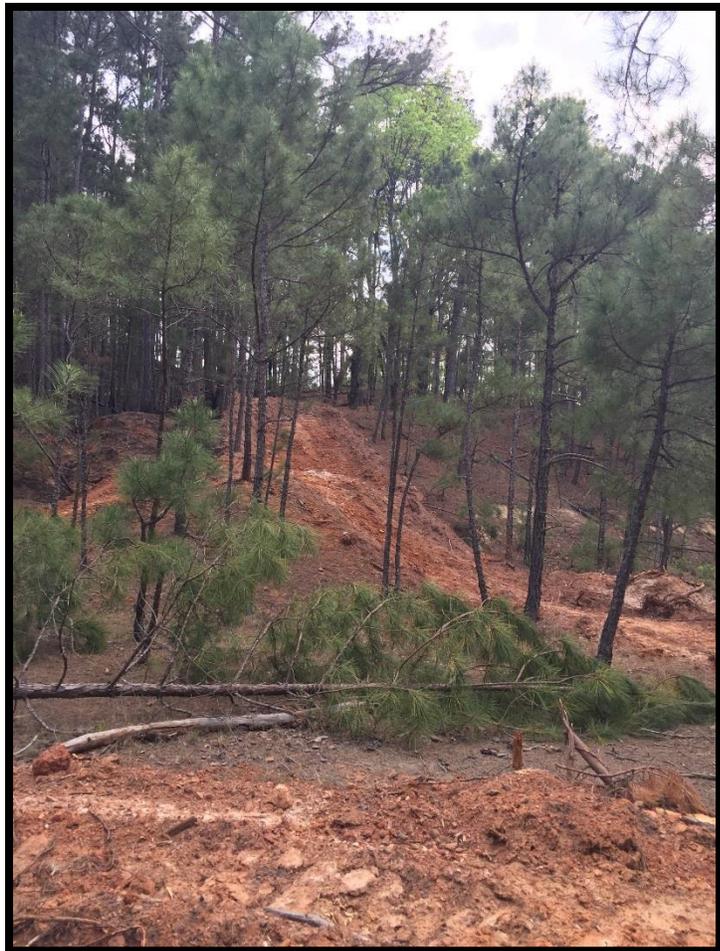
Dozer line running up slope were the incident occurred with the secondary line from equipment recovery mid-slope to the left.

At approximately 19:40 the IC was scouting lines via UTV to prepare for a burn out. The IC came to a steep slope. The lower 15' section was steepest at roughly 70% to 80% slope (35° to 39°). The IC started up the slope with the UTV. The UTV was roughly 10 feet up the slope when the IC realized the UTV could not make it up the hill. He let off the throttle and the UTV rapidly began to coast backwards. The operator hit the brakes, causing the front tires of the UTV to come off the ground. The UTV began to slowly stand straight up, then continued to roll backwards. The UTV landed on its roof with the front facing downhill. The IC was not wearing a seatbelt and was knocked onto the roof of the UTV when the rollover occurred.

With daytime operations transitioning into night ops, the unseen portion of constructed dozer line was perceived as “not that bad.” However, the slope exceeded the capabilities of the machine and resulted in a roll over. Be sure to scout any lines on foot that have potentially hazardous terrain or could cause potential issues to equipment operations. Scouting is dangerous, how much more risk is assumed while scouting on a UTV/ATV?

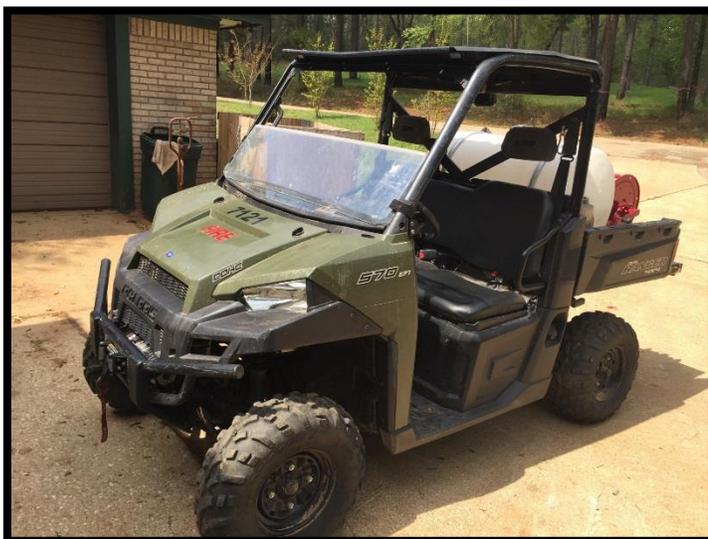
The UTV after return to the local office. Note the bow in the roof from the roll over.
