Gotier Trace Prescribed Fire

Equipment Loss - FLA

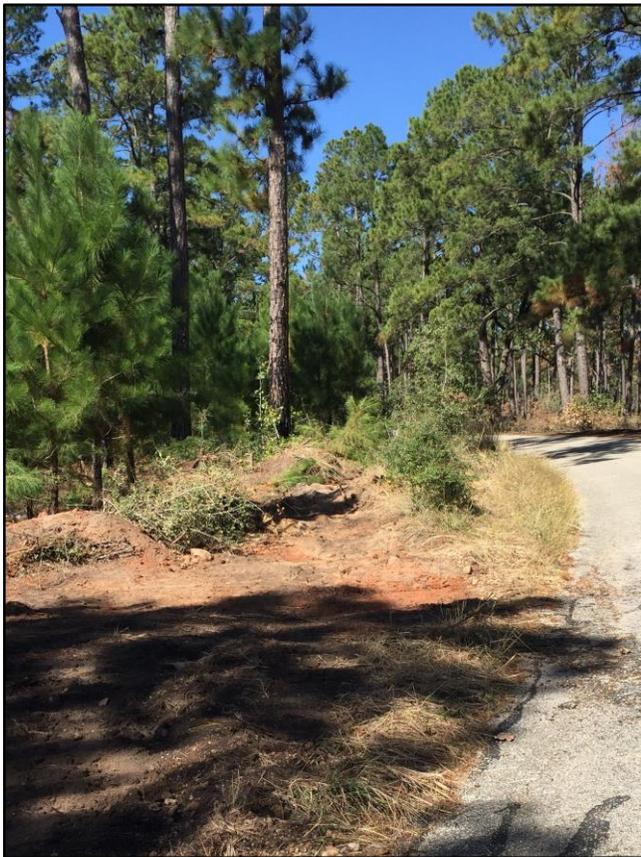
Transport parking location at spot fire #1

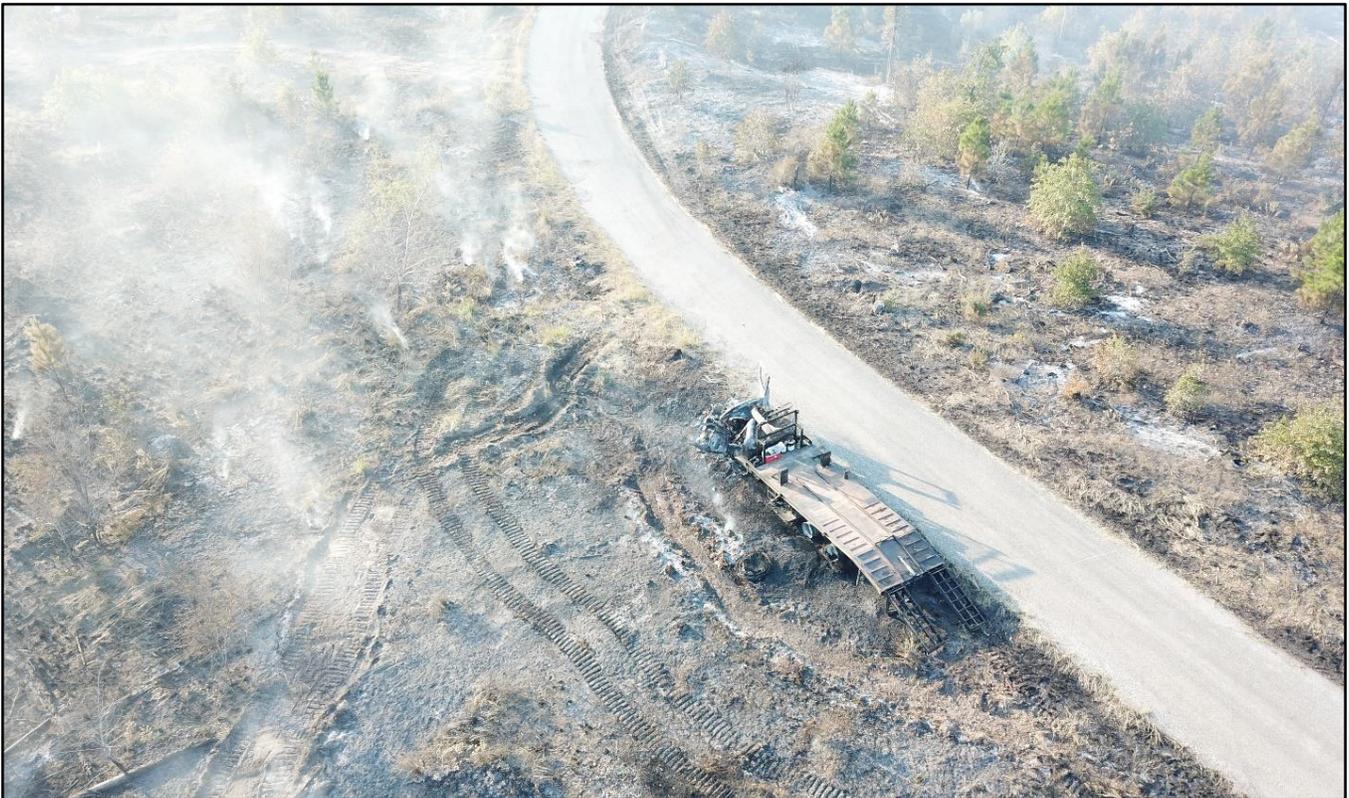
IN THIS PICTURE THERE IS AN ASH PILE AT THE TOP AND TO THE RIGHT OF THE ROAD (PR1C). THIS IS WHERE EMBERS WERE LOFTED ACROSS THE ROAD, IGNITING SPOT #2. THE DZOP IDENTIFIED THE PARKING LOCATION AS BEING SPARSELY VEGETATED AND CLOSE ENOUGH TO QUICKLY ATTACK THE SPOT. ENG1 WAS ALREADY ENGAGED IN SUPPRESSION ON PR1C. DZ1 PLOWED LINE AROUND THE TRANSPORT BUT DID NOT CONNECT IT TO THE ROAD. DUE TO ENG1 BEING NEARBY, CONCERNS OVER DAMAGING THE ROAD, AND THE RELATIVE EASE OF SUPPRESSING SPOT #1, THE DZOP FELT COMFORTABLE LEAVING THE TRANSPORT AND ATTACKING THE FIRE.

DZ1 TRACKED TO THE LEFT FLANK AND BEGAN BLADING LINE AROUND SPOT #2. THE SPOT PRESENTED CONTAINMENT ISSUES AND BEGAN JUMPING THE DOZER LINE. ENG1 WAS REQUESTED TO PROVIDE SUPPORT. THE SWAMPER RETURNED TO CHECK ON THE TRANSPORT AND NOTED MULCH IN THE PLOW LINE BUT FELT COMFORTABLE WITH THE LOCATION. DURING THIS TIME, MULTIPLE RESOURCES PASSED BY THE TRANSPORT AND FELT COMFORTABLE WITH WHERE THE EQUIPMENT WAS PARKED. WHILE WORKING ON SPOT #2, ENG1 HEARD TIRE EXPLOSIONS, RETURNED TO THE TRANSPORT AND FOUND IT ON FIRE.

IT IS STILL UNCLEAR IF ADDITIONAL EMBERS SPOTTED ACROSS THE LINE OR IF FIRE FROM SPOT #2 FLANKED THE FIREFIGHTERS AND IGNITED THE TRANSPORT.

Similar to safety zones, there are various factors that influence how we secure equipment. Fuels, current and expected fire behavior, topography, land use considerations, and human factors should all be considered in the decision making process. Common practices include parking in cold black or a previously cleared location, building a safety zone for equipment or building a line around the equipment. If needed, transports can be relocated to a separate location once the dozer has been unloaded. Refer to page 8 in the IRPG for safety zone considerations.

Other considerations are to ensure that equipment is free of debris, the size of the parking location is adequate for the equipment, is accessible and can be readily moved (i.e. Keys left in ignition, ramps put back up, chains left on deck, etc.).

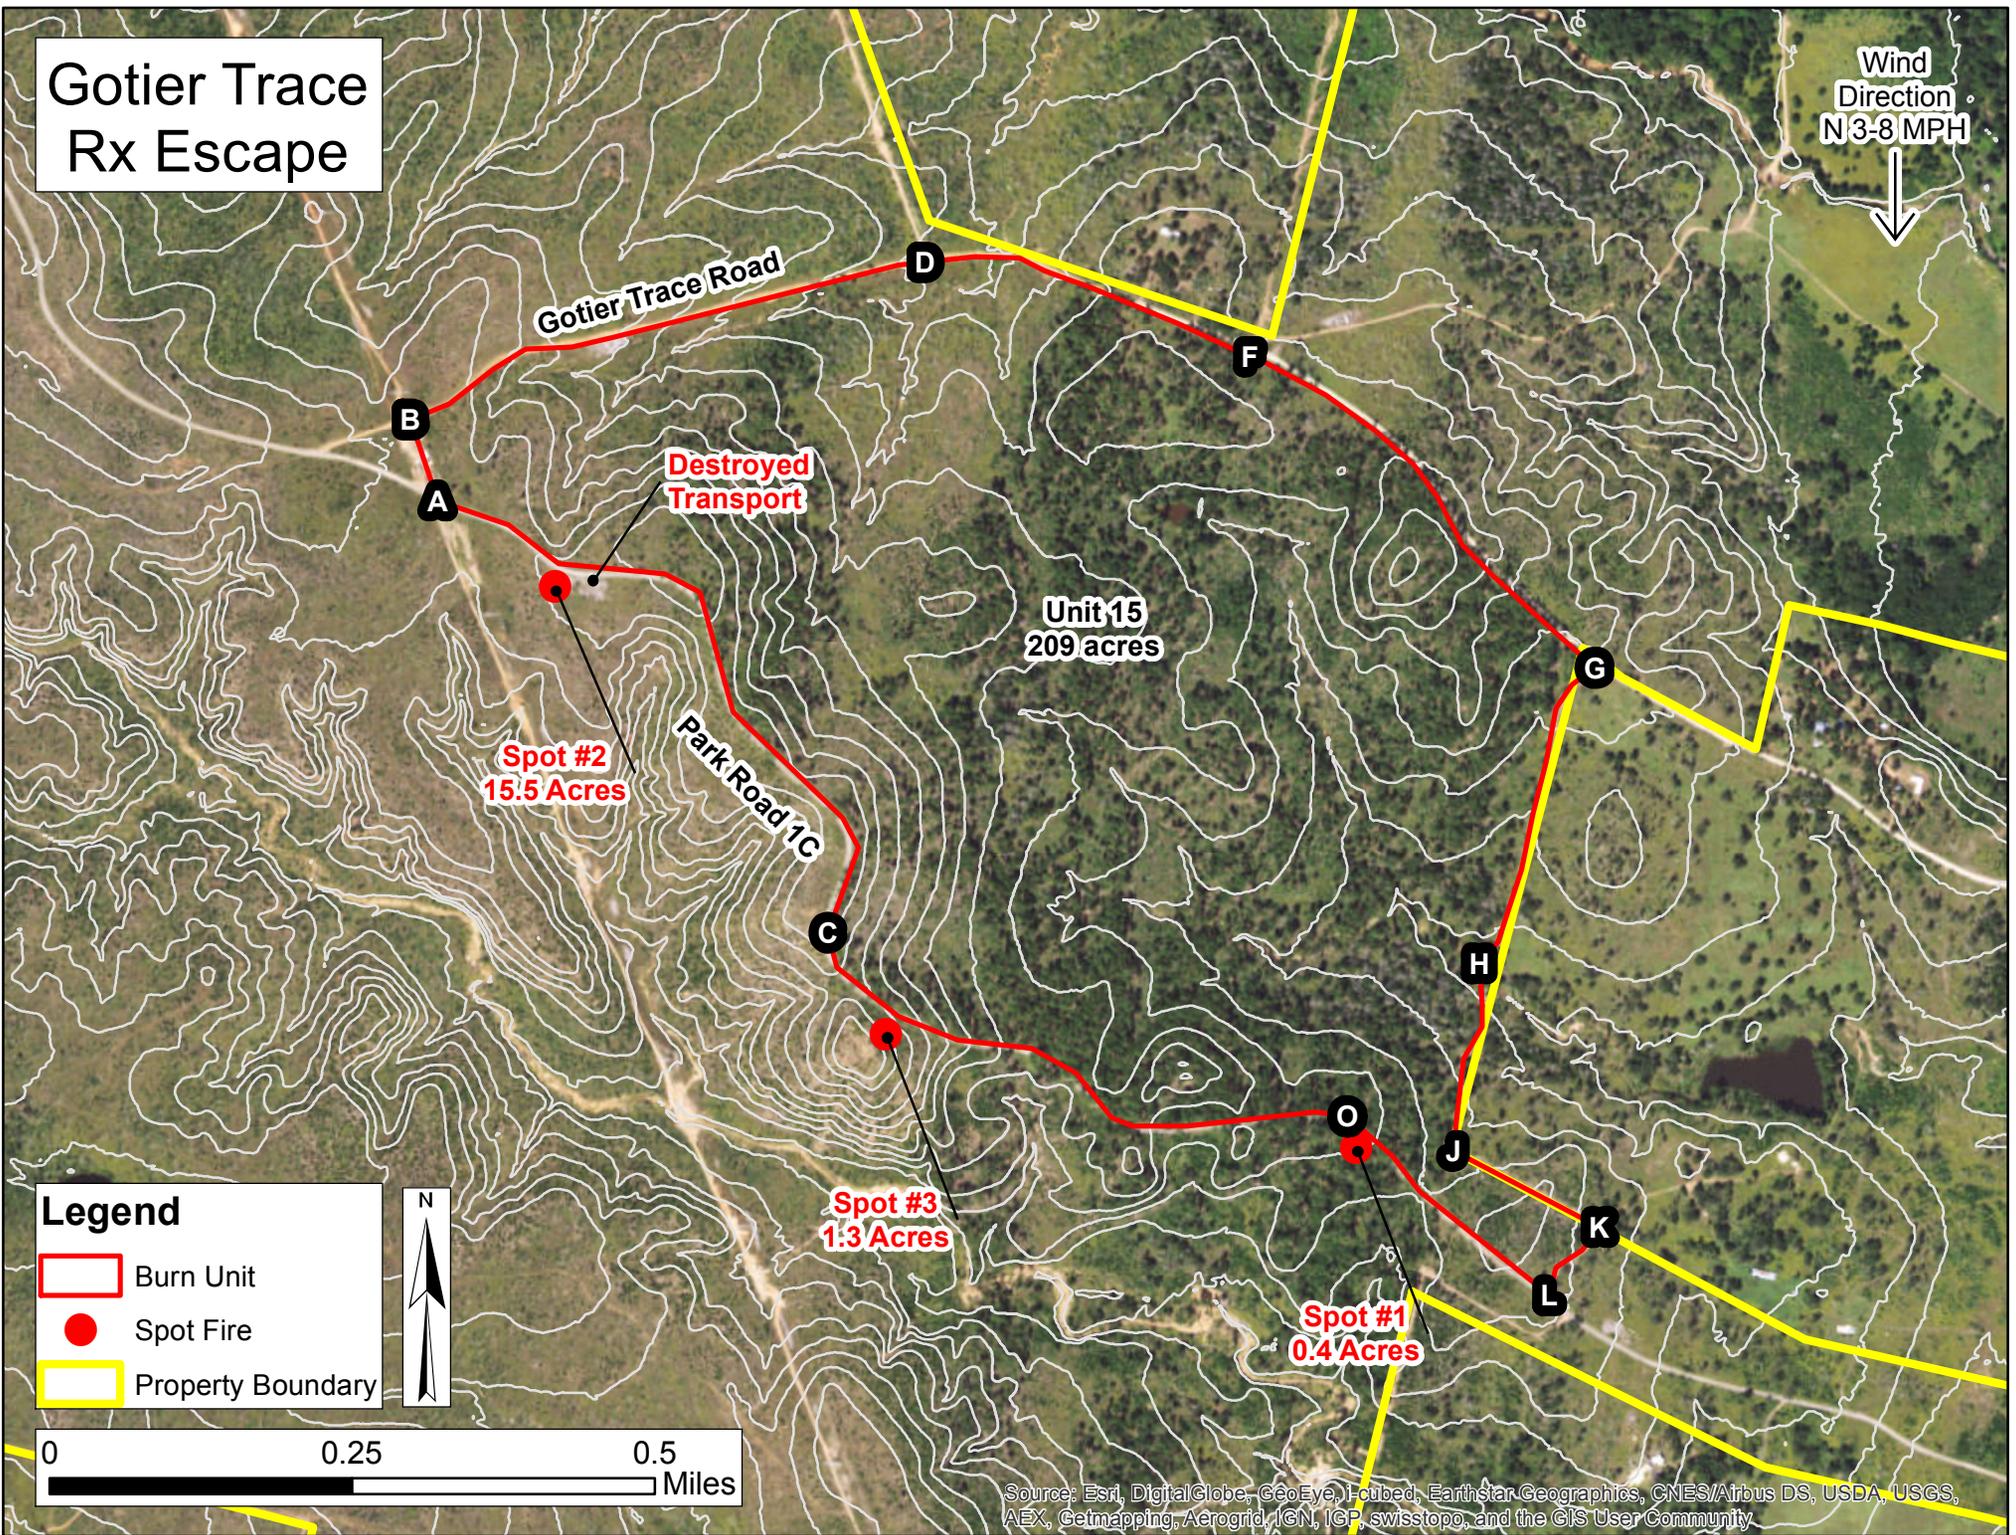
Gotier Trace Rx Escape

Ignitions from DP-L to DP-A was completed at 14:20. Ten minutes later a spot fire (#1 on map) occurred near DP-O in needle cast. The contingency dozer

At 15:35, another spot fire (#2 on map) was reported near a previously mulched area by DP-A. DZ1 was mobilized for the spot. The DZOP recognized that the black in the burn unit was too hot for a parking location. The DZOP was also concerned with damaging the road by tracking across it. The decision was made to park in a sparsely vegetated area of the green, near the spot fire. ENG1 was nearby and the DZOP felt comfortable leaving the transport. Poor visibility due to smoke was also becoming a concern at this point.
