Transport + Wooden Bridge = Near Miss

LESSONS SHARED

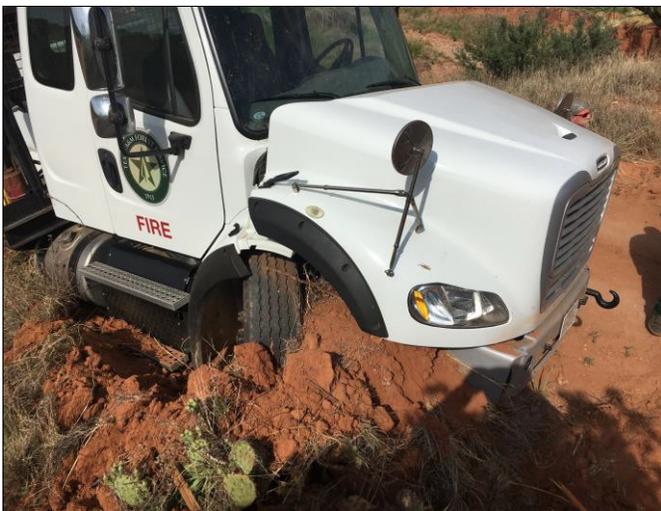
The next morning, a strike team of dozers was assigned to the Prairie Grove Fire led by Strike Team Leader (STEQ) Larry and Heavy Equipment Boss (HEBQ) Howard. Around 09:30, resources arrived at CR 27 and Hwy 256 and met with Tim who provided a briefing of the fire and access route including the bridge crossings. Tim told resources there was no weight-limit sign but he had inspected the bridge and felt comfortable taking the equipment across. The strike team knew Tim's experience level and felt comfortable with his assessment. As the convoy approached the first bridge at 09:45, Tim instructed crews to keep their wheels on the steel runners. As the first transport crossed the bridge, the second slowed to let it clear and then proceeded across. After the first two crossed, Transport #3 (Phil) "felt confident" crossing the bridge and proceeded, focusing on keeping the tires on the steel runners. Phil was crossing the bridge when he felt the transport pull right. Realizing his rear right tires had broken through the wooden deck, he turned the wheel left to correct. The next thing he knew, the transport was resting in an embankment. Phil had made it across the bridge but the rear tires had veered off the metal runners and broken through a section of the wooden decking.

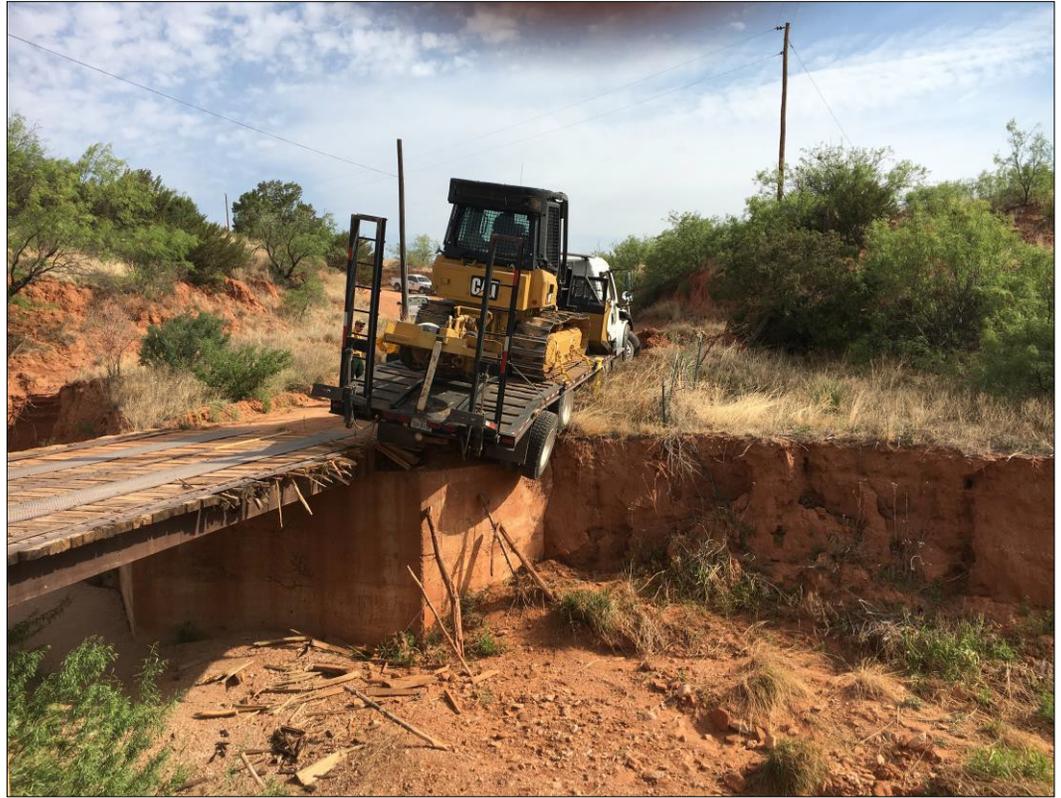
Larry and Howard’s plan was to unload two dozers and clear the front of Phil’s transport by pushing dirt away from the front bumper. Then they would winch the transport back onto the road. The second dozer was staged to assist. The plan was successful and the transport was recovered back to the road. The transport had a damaged steering rod, front bumper, and hood and firefighters determined it would not be safe to travel any further. The dozers were loaded by 10:20 and the strike team continued to the Prairie Grove Fire.

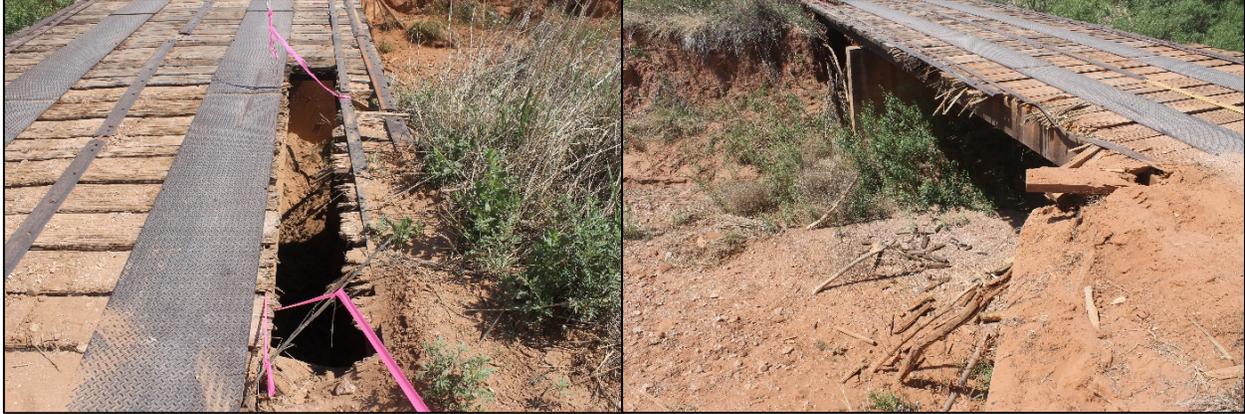
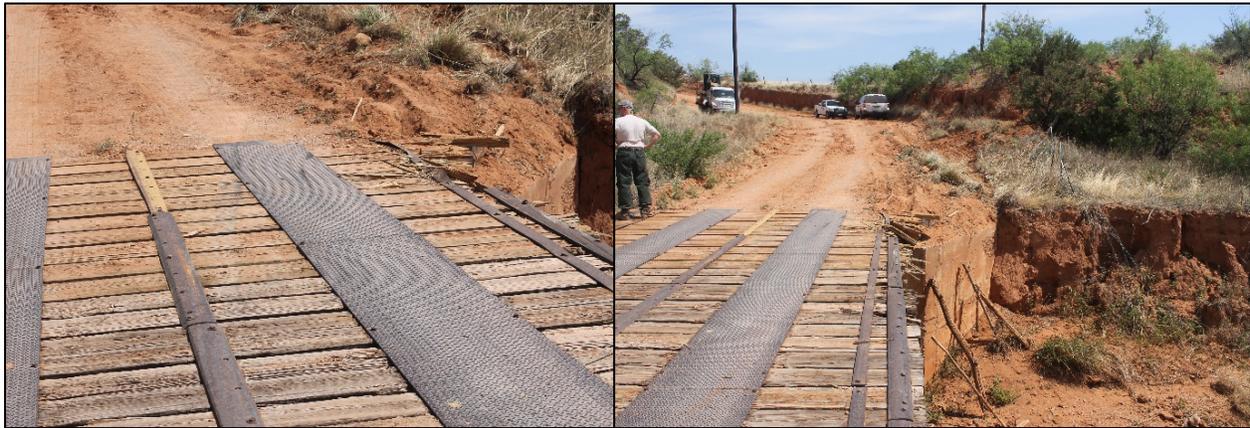
Initial bridge damage when transports crossed bridge accessing the fire

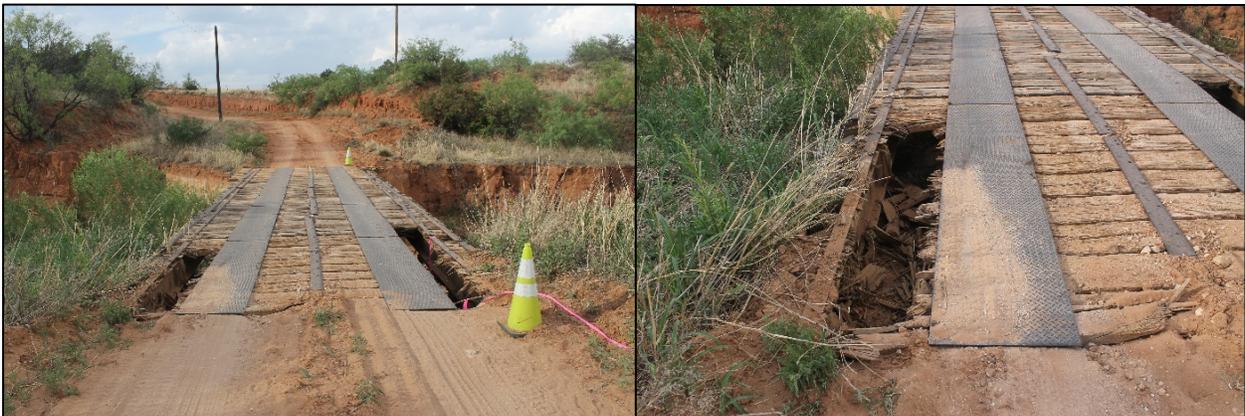
Additional bridge damage after transports crossed bridge departing fire
