### Background

Over the last few months, the Task Force has been assigned to a fuels project along Park Road 1C in Buescher State Park. The project area (28 acres) consisted of Yaupon, Juniper, Oak, and scattered Loblolly Pine. Once completed, the area will provide a break in fuels for several private and public properties that have been threatened by wildfires in the past.

#### Incident One

## Incident Two

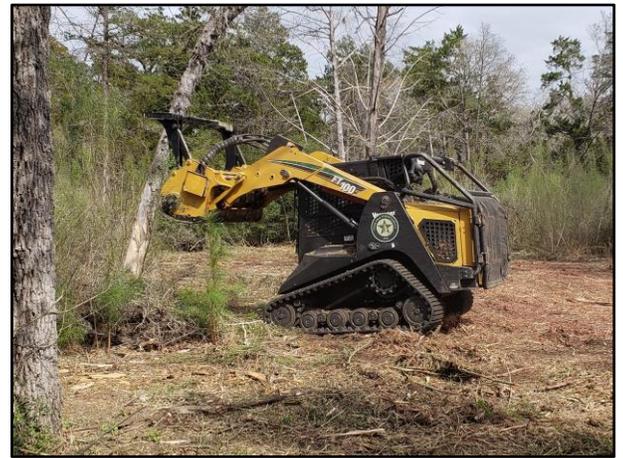
Picture 1: Vermeer FT100 Mulcher

After a few hours of mulching, Tim smelled smoke, maneuvered the machine back onto the road, and shut it down. However, he realized that the boom was still lifted, blocking his exit from the cab. He started the engine up, lowered the boom, shut it back down, and exited the cab. After exiting the machine, he noticed light smoke and flames but then heard a pop and noticed that the amount of smoke decreasing. Then, he hiked up a hill to get cell service. He called 911, his supervisor, and made a call over the radio to his home unit. He grabbed a fire extinguisher from his truck and returned to the machine. When he arrived at the machine, he noticed that the fire intensity had increased and began burning mechanical parts. He tried using the extinguisher but it was ineffective due to the location of the fire.

After receiving the call, the home unit decided to send a Type III engine to the site. The local Volunteer Fire Department (VFD) sent two engines. The Type III arrived and suppressed the fire before the VFD engines arrived on scene. Suspected cause of the fire is debris build-up in the engine compartment.

- Clear debris build-up from machine twice a day or more if necessary
- Full wash; minimum once every two weeks
- Pretreat any debris that can't be removed from belly pan with water
- Operate it like you're personally paying for any repairs

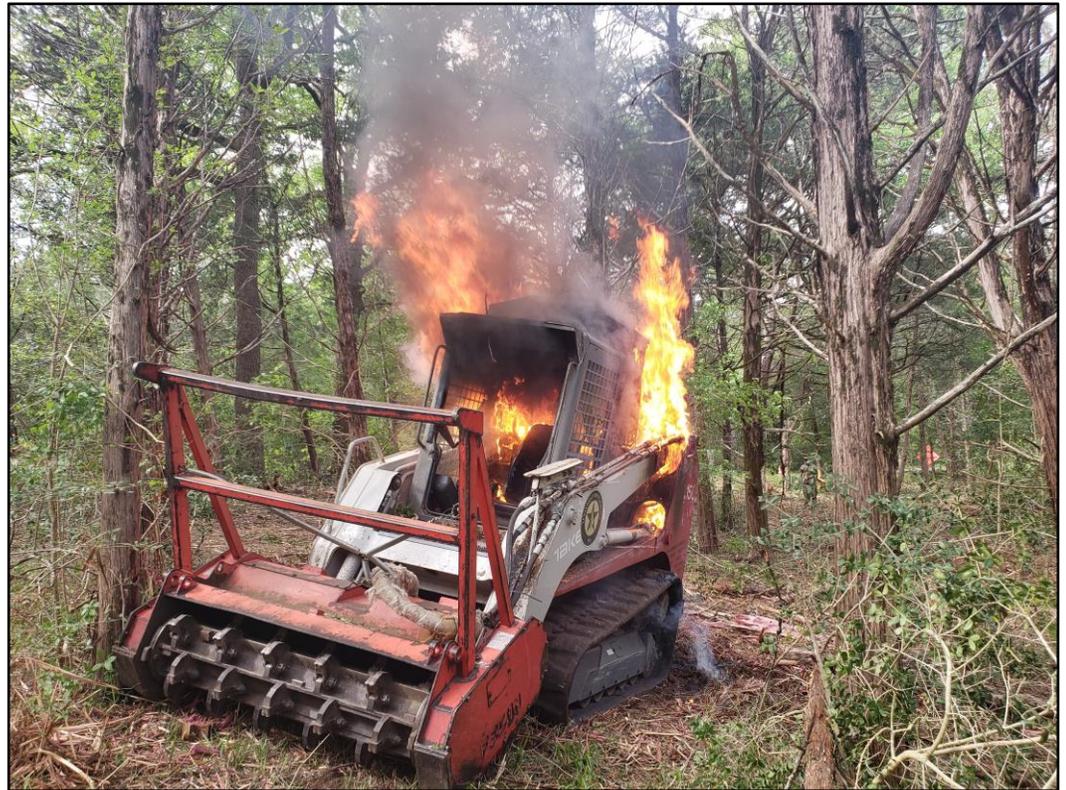
The plan for the day was for Tim to serve as a trainer/swamper. Bob began working by clearing Juniper. After an hour of operation, the machine lost engine power but the dash lights were still on. As soon as the machine lost power, the cab filled with smoke. After some difficulty opening the cab door, Bob exited the machine. Tim heard the machine shut down, looked over and saw smoke. After checking with Bob, Tim hiked up the road to get cell service. He called 911, his supervisor, and his home unit. While Tim was making calls, Bob watched the machine billow white smoke and become fully engulfed. Bob states that this all occurred within a minute and a half of exiting the machine.

Picture 2: Takeuchi fully engulfed on April 16

Again, the home unit and local VFD both sent engines. The fire extinguisher had not been replaced after the last use but due to the intensity of the fire, it is suspected that the extinguisher would not have made a difference. The home unit's Type VI and local VFD engine arrived at about the same time. Due to pump issues on the VFD engine, the Type VI ran a hose line and suppressed the fire within a few minutes. Suspected cause of the fire is due to mechanical failure.

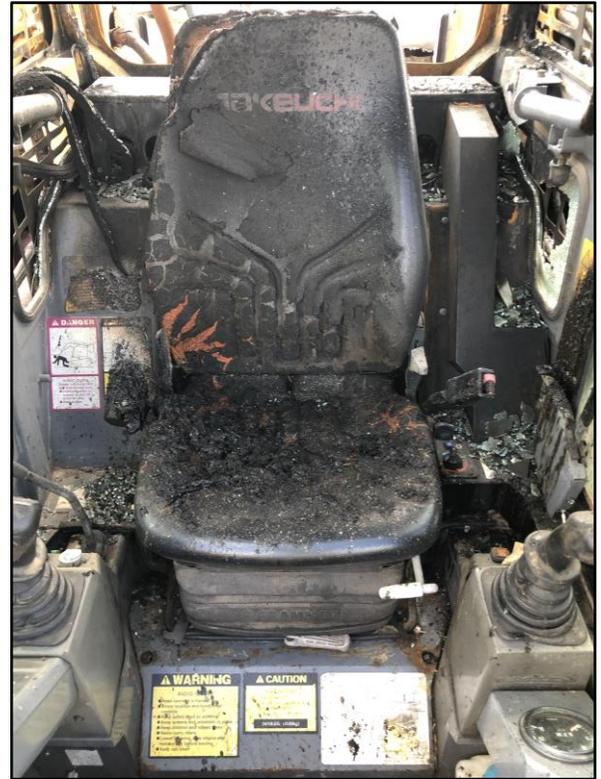
Picture 3: Operator's seat in Takeuchi after incident
