Pipeline Near Miss

Lessons Shared

On July 20, 2019, Texas A&M Forest Service (TFS) resources were requested to the Oglesby Fire in Schleicher County, Texas. While performing initial attack operations, a dozer had a near miss with an 18-inch high-pressure hazardous liquid pipeline.

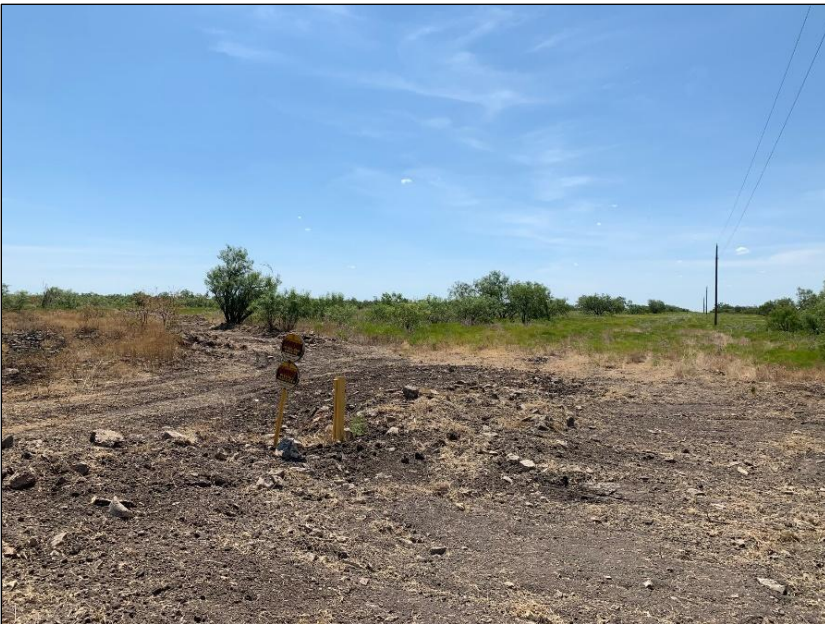
Dozer line across the first of three pipelines

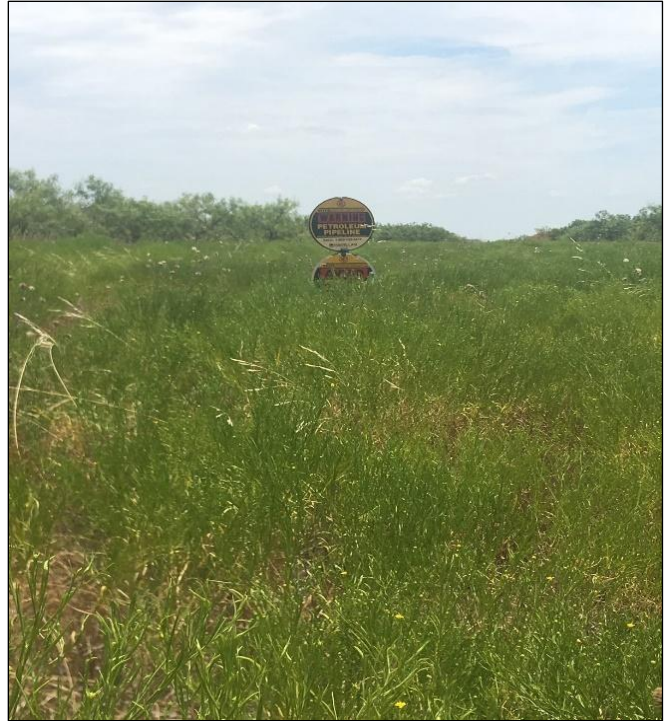
This picture depicts the thick broomweed fuel conditions along the pipeline right of way

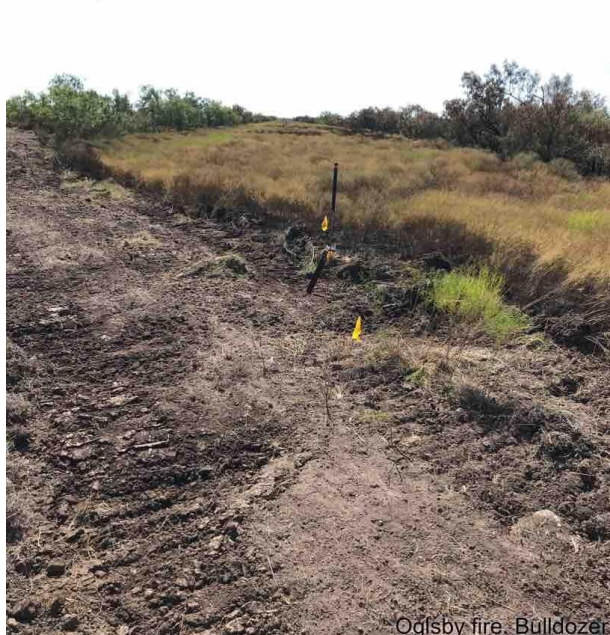
Dozer line crossing pipeline right of way

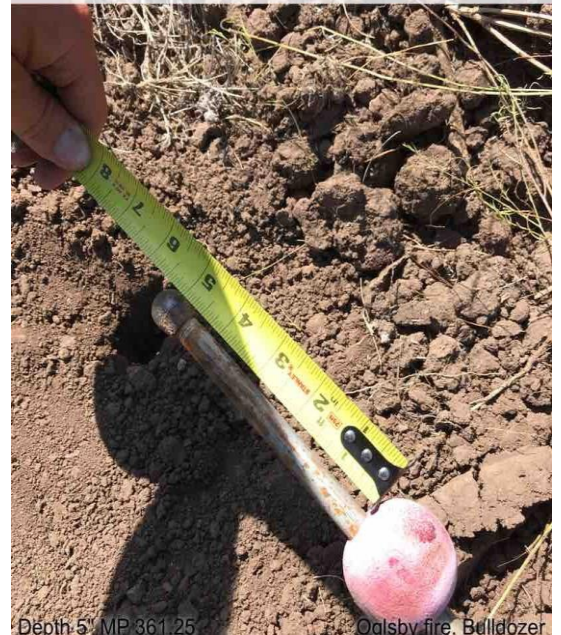
On July 24 2019, a damage prevention specialist with the pipeline company notified the RFC that dozer line had been constructed on top of their pipeline and one location had come within 5 inches of striking an 18-inch high-pressure liquid gas line. The pipeline was buried 12 inches below ground level at this location. The pipeline representative explained that this particular pipeline's depth is anywhere from 12-inches to ground level in some areas. It was installed in the 1940s before depth regulations were in place and is still heavily utilized by the oil industry.

Depth gauge showing approx. 5" from dozer line to pipeline
