Cottonwood Medical Incident

Lessons Shared

On June 10th, 2020, Texas A&M Forest Service (TFS) resources returned to the Cottonwood Fire in Reeves County, Texas. While performing mop-up operations, a firefighter assigned to a Type-3 engine was injured after stepping into an ash pit.

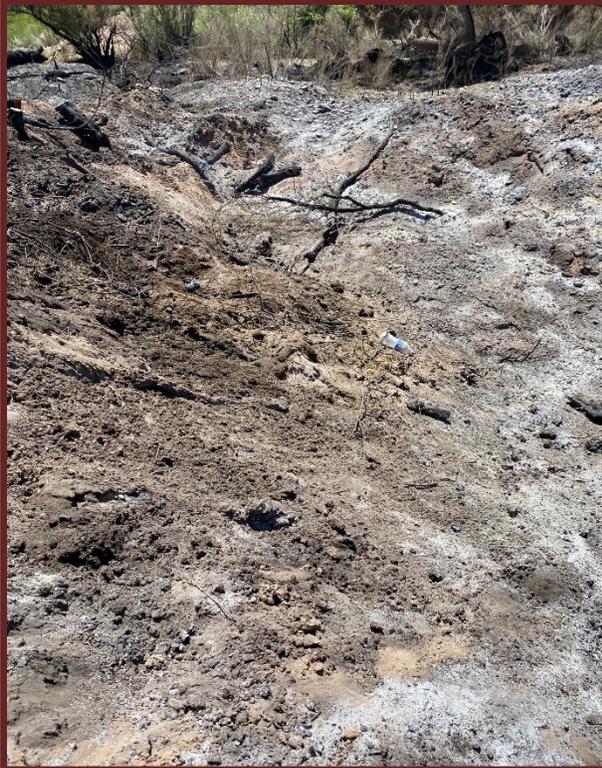
Area of where incident happened. Note water bottle marks the spot injury occurred.

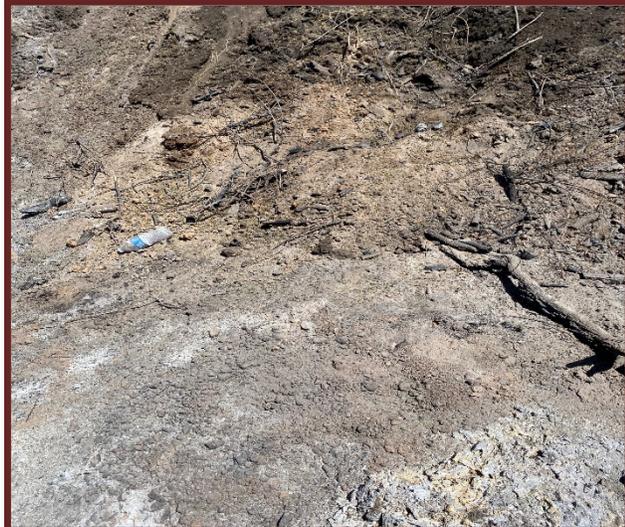
Water bottle marks spot where ENOP fell in ash pit.
