Southside Trailer Fire

Texas A&M Forest Service (TFS) resources were requested for assistance on the South Side Alpha Fire in Childress County in early November. Upon arriving at the incident, resources identified a staging area and unloaded their equipment. Shortly after unloading the dozers, the fire began to impact the staging area, which resulted in damage to one transport unit and two trailers.

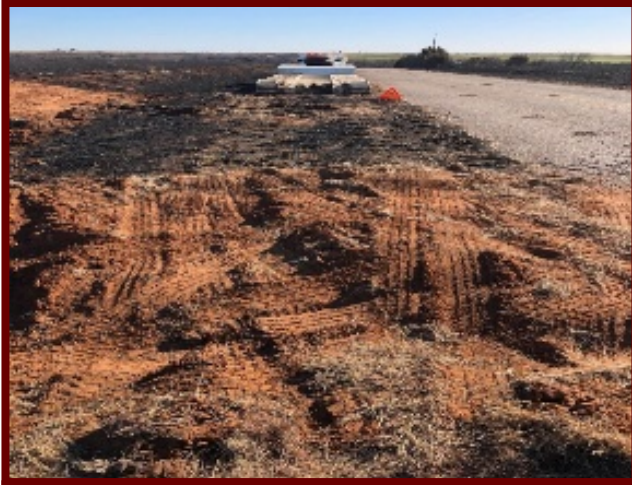
Picture 2: TFS staging area after fire burned through.

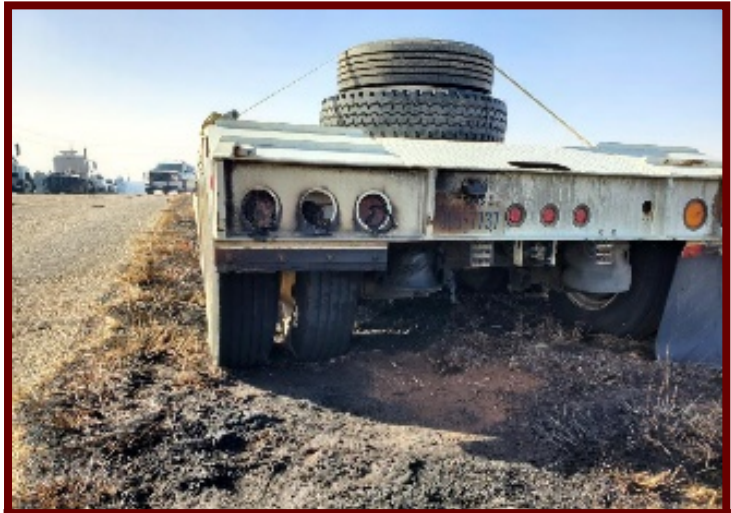
Picture 3: The disabled Trailer after fire was suppressed.

While the HEQB worked to suppress the spot fires, the DZIAs were able to finish securing their blades. DZIA 1 began to push a check line around the transports, but noticed a code on the dozer that required him to shut down. At this time, he noticed that a mud flap was on fire on his trailer, which allowed the fire to establish around the tires and eventually the rest of the trailer. DZIA 2 walked his dozer on to the road to escape the fire.

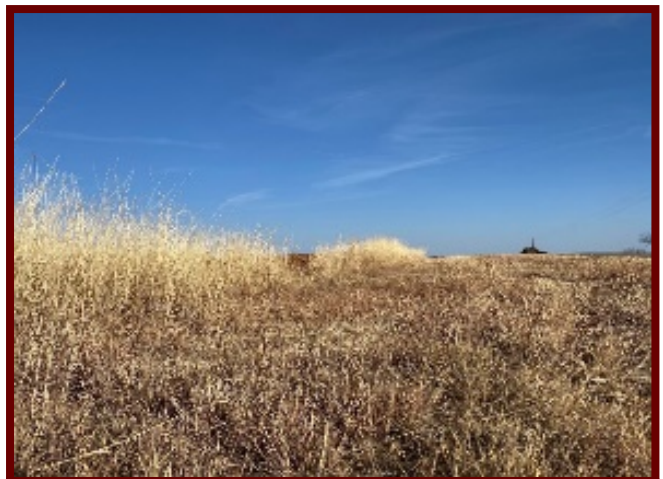
Picture 5: Fuels representative of TFS staging area.

Although it is always the first choice to avoid parking in unburned fuel, the crew determined there was not an adequate area to do so. Given the low fire activity on the Bravo fire, the crew felt that their parking spot was sufficient. Constructing line around staging areas is a common practice. The plan was to construct a line around the transports prior to engaging. Similar to safety zones, there are various factors that influence what we consider sufficient. Fuels, current and expected fire behavior, topography, land use considerations, and human factors should all be considered in the decision-making process. Common practices include parking in cold black or a cleared location, building a safety zone for equipment or building a line around the equipment. If needed, transports can be relocated to a separate location once the dozer has been unloaded. Refer to page 8 in the IRPG for safety zone considerations.
