## Dozer Fire Lesson Shared

### ***“There’s a dozer on fire.” -Air Attack***

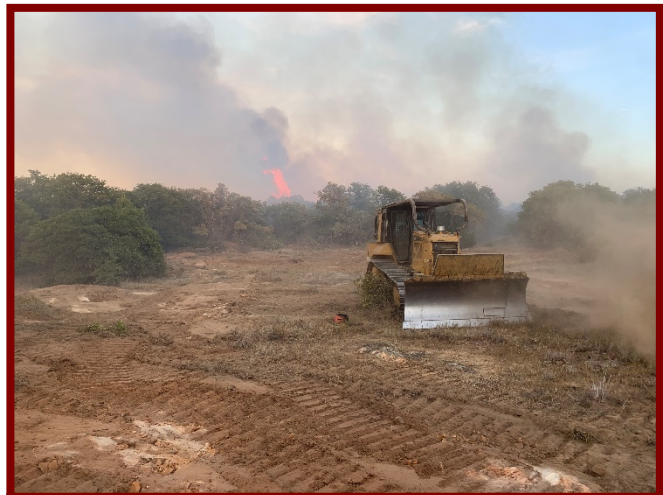
**Picture 1: The disabled dozer after the engine compartment fire was suppressed.**

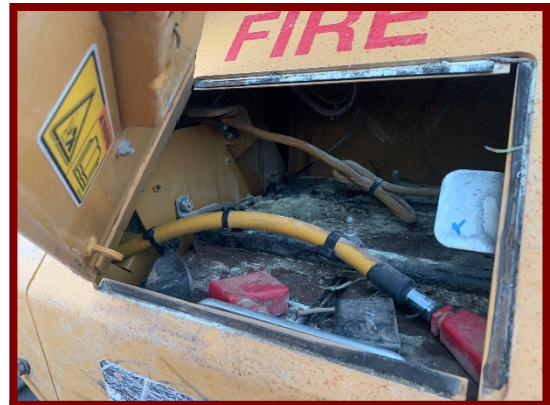
**The cause of the fire is currently undetermined, while the FLA team Subject Matter Expert is working with CAT mechanics to locate which compartment the fire originally started.**

**Picture 3: Battery box where the fire was first observed by the operator.**

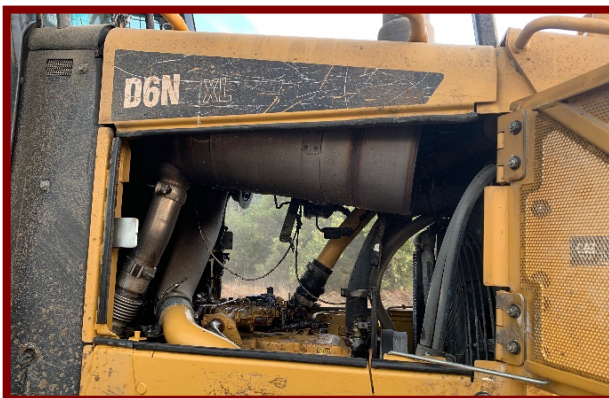
**Picture 4: Fire damage in the dozer engine compartment.**
