Gotier Trace Prescribed Fire

Equipment Loss - FLA

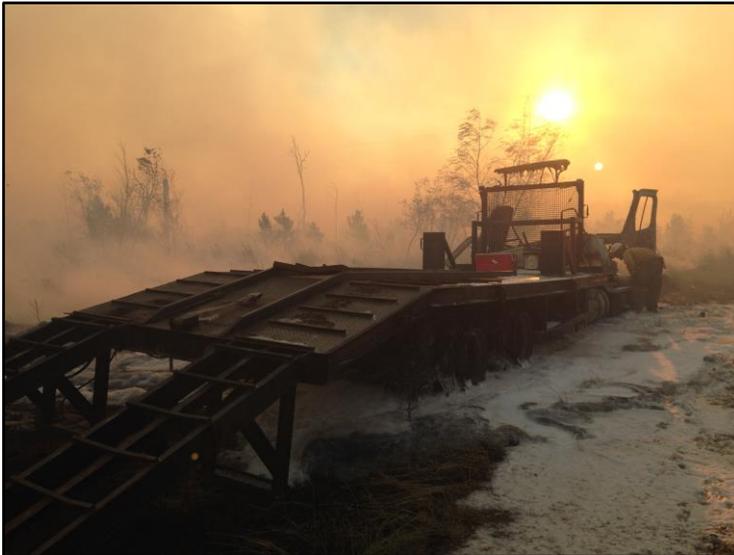
At 16:30, containment was lost at multiple locations on spot fire #2. DZ1 notified the RXB2 that they were having issues with containment and requested additional resources. Additional dozer support was requested by the RXB2 through ENG1. Around 17:00 personnel reported hearing tires exploding. The RXB2 was notified by ENG1 that the transport was fully engulfed. Local fire department assistance was requested by the RXB2 for the transport fire.

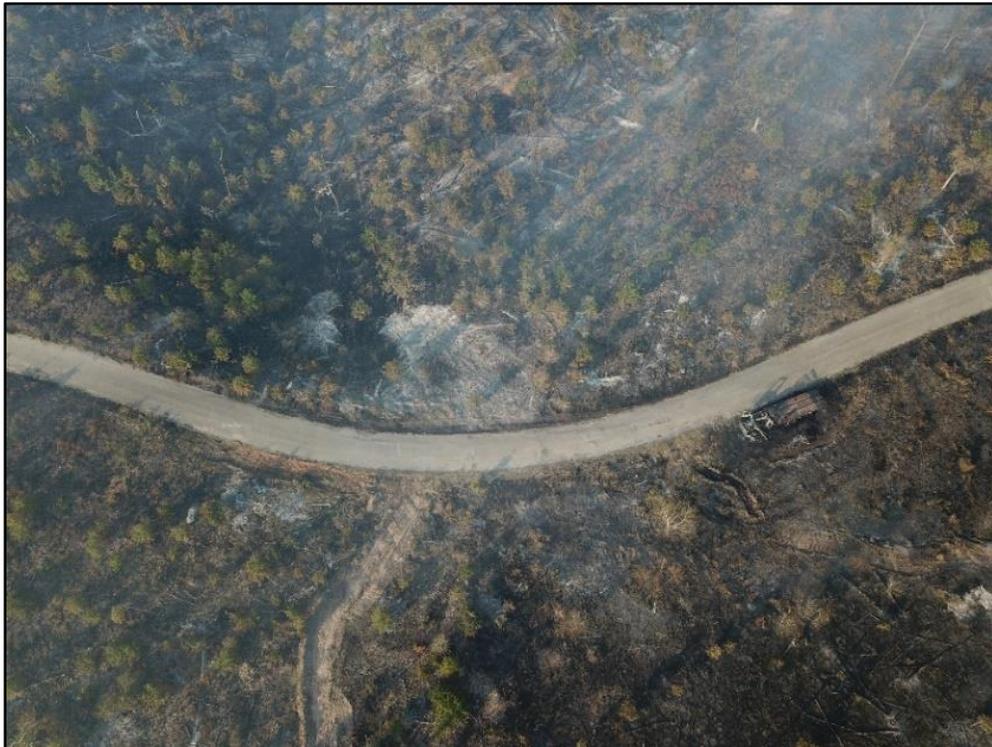
IN THIS PICTURE THERE IS AN ASH PILE AT THE TOP AND TO THE RIGHT OF THE ROAD (PR1C). THIS IS WHERE EMBERS WERE LOFTED ACROSS THE ROAD, IGNITING SPOT #2. THE DZOP IDENTIFIED THE PARKING LOCATION AS BEING SPARSELY VEGETATED AND CLOSE ENOUGH TO QUICKLY ATTACK THE SPOT. ENG1 WAS ALREADY ENGAGED IN SUPPRESSION ON PR1C. DZ1 PLOWED LINE AROUND THE TRANSPORT BUT DID NOT CONNECT IT TO THE ROAD. DUE TO ENG1 BEING NEARBY, CONCERNS OVER DAMAGING THE ROAD, AND THE RELATIVE EASE OF SUPPRESSING SPOT #1, THE DZOP FELT COMFORTABLE LEAVING THE TRANSPORT AND ATTACKING THE FIRE.

DZ1 TRACKED TO THE LEFT FLANK AND BEGAN BLADING LINE AROUND SPOT #2. THE SPOT PRESENTED CONTAINMENT ISSUES AND BEGAN JUMPING THE DOZER LINE. ENG1 WAS REQUESTED TO PROVIDE SUPPORT. THE SWAMPER RETURNED TO CHECK ON THE TRANSPORT AND NOTED MULCH IN THE PLOW LINE BUT FELT COMFORTABLE WITH THE LOCATION. DURING THIS TIME, MULTIPLE RESOURCES PASSED BY THE TRANSPORT AND FELT COMFORTABLE WITH WHERE THE EQUIPMENT WAS PARKED. WHILE WORKING ON SPOT #2, ENG1 HEARD TIRE EXPLOSIONS, RETURNED TO THE TRANSPORT AND FOUND IT ON FIRE.
