Transport + Wooden Bridge = Near Miss

LESSONS SHARED

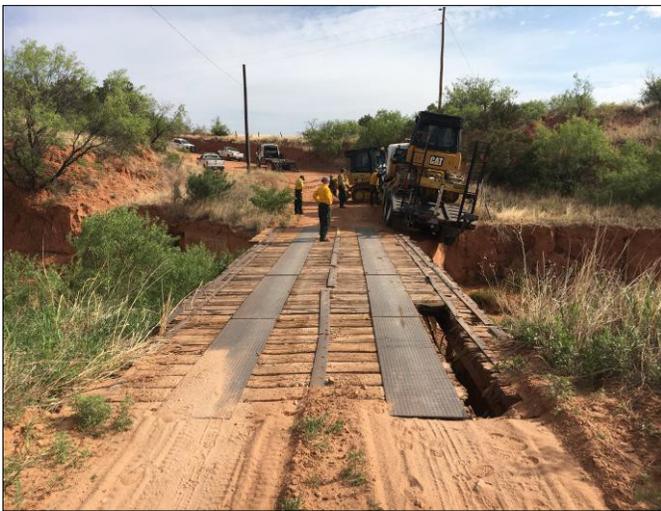
On May 12, 2018, Division Supervisor (DIVS) Tim was staffing the Glover Fire in Briscoe County, Texas when he observed a dry lightning strike. Tim received approval to locate and size-up the new start. He met with the landowner and began scouting access into the fire. After 2 hours of searching, Tim located a 15-acre fire and named it the Prairie Grove Fire. Tim determined County Road (CR) 27 would be the most direct option for access. Tim observed several low water crossings and two bridges. The first bridge was 25 feet long and 10 feet high, had no weight-limit sign, was constructed of steel and concrete with a wooden deck and steel runners. The landowner told Tim that he had taken several pieces of large equipment and an 18-wheeler across the bridge with no issues. The second bridge was constructed completely with concrete. Having years of experience with heavy equipment, Tim felt comfortable that a bobtail transport with a dozer could cross the bridges. With minimal fire behavior and loss of daylight, Tim requested resources for the following morning.
