Northside Post-Fire Report 755 Acres Walker County, TX October, 19th 2015

Northside Fire Environment

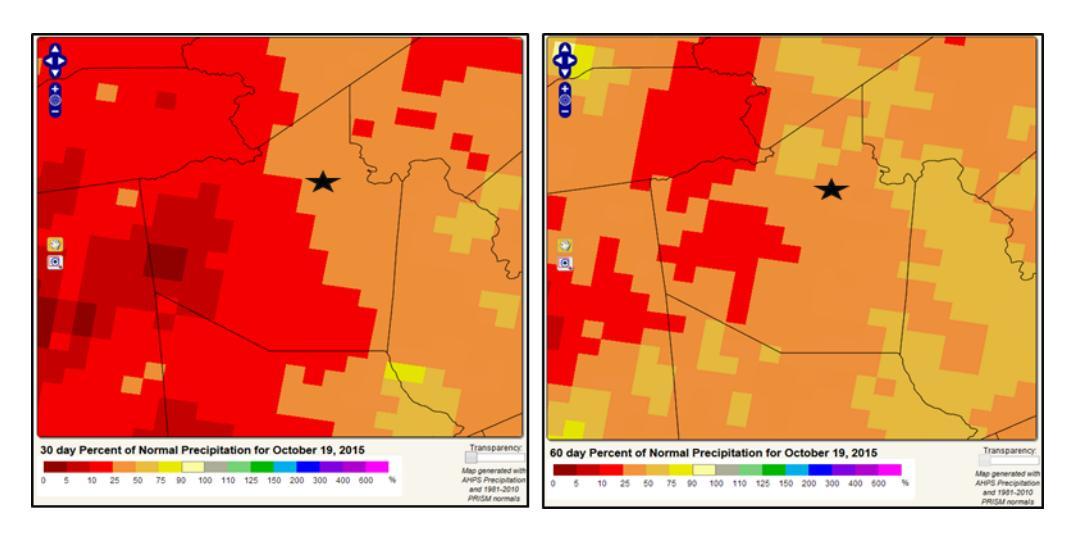
The 60-day Percent of Normal rainfall map (left) indicates much of the county receiving 25-50% of normal rainfall with less than 25% amounts appearing in the west and northwest part of the county. Where the Northside Fire occurred (black star), it is located near the edge of the of less than 25% area of observed rainfall over the 30 day period (right).

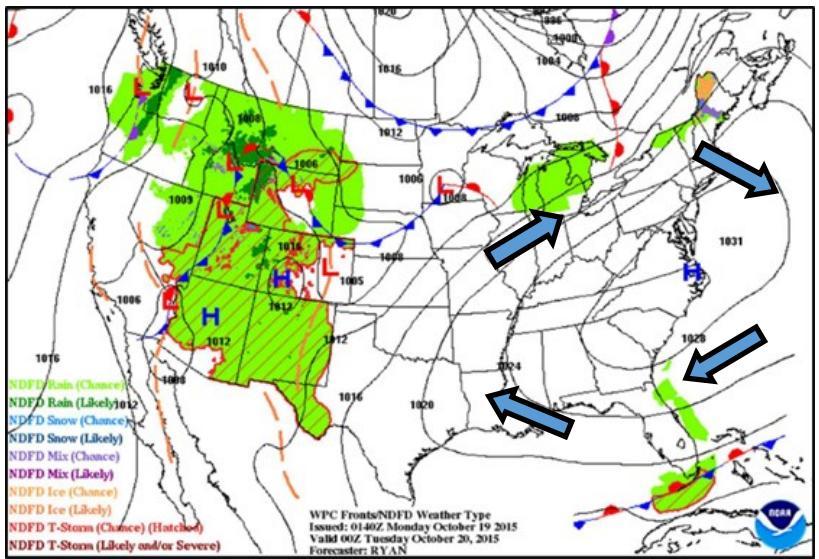
A dry cold front passed through the state over the weekend of the 17th ushering very dry air and seasonable temperatures. Surface high pressure that was located in the Central Plains shifted eastward by Monday.

Clockwise rotation around the high pressure center allowed for East-Southeasterly winds to prevail with drier air remaining in place with low Dew Point temperatures and Relative Humidity.

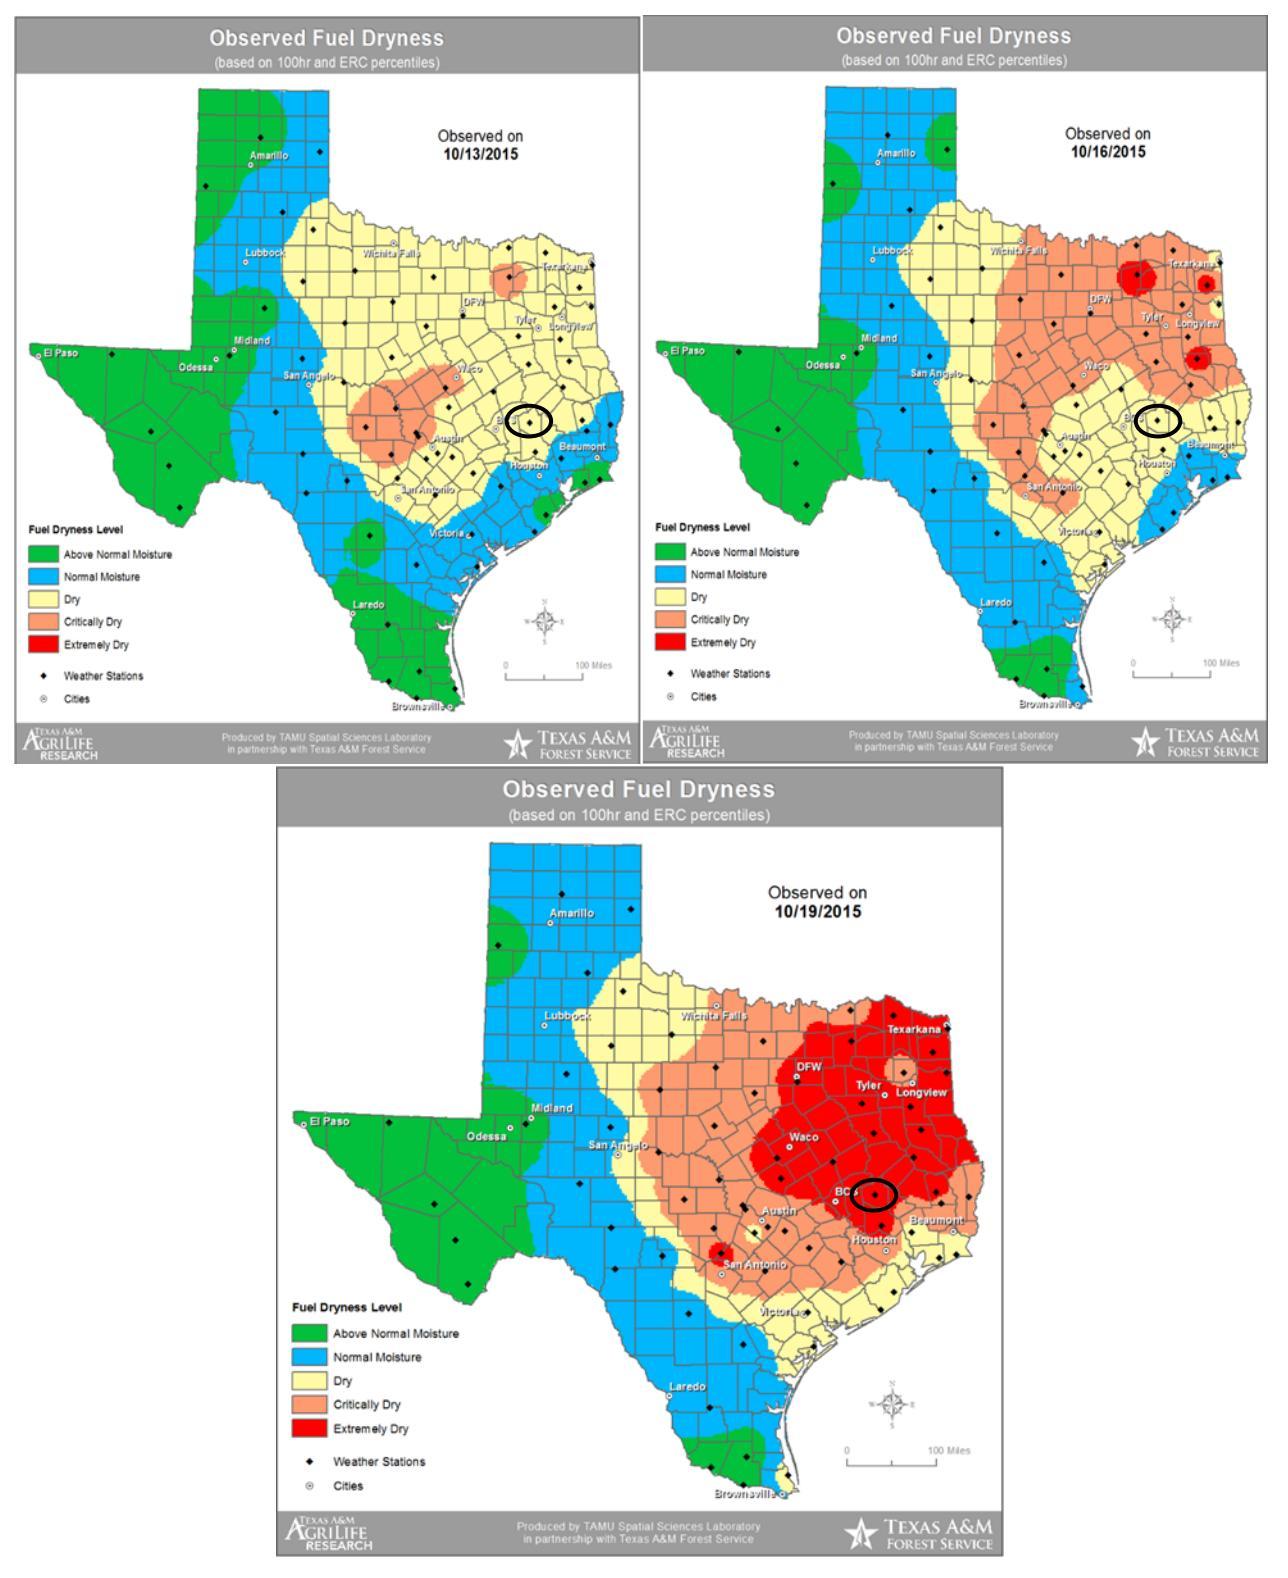
By October 19th, Extremely Dry Fuels began were widespread throughout East Texas, including Walker County. Parts of Central and North Texas also observed extremely dry fuels. This rapid change, or accelerated drying can be attributed to dry air mass that moved into Texas.

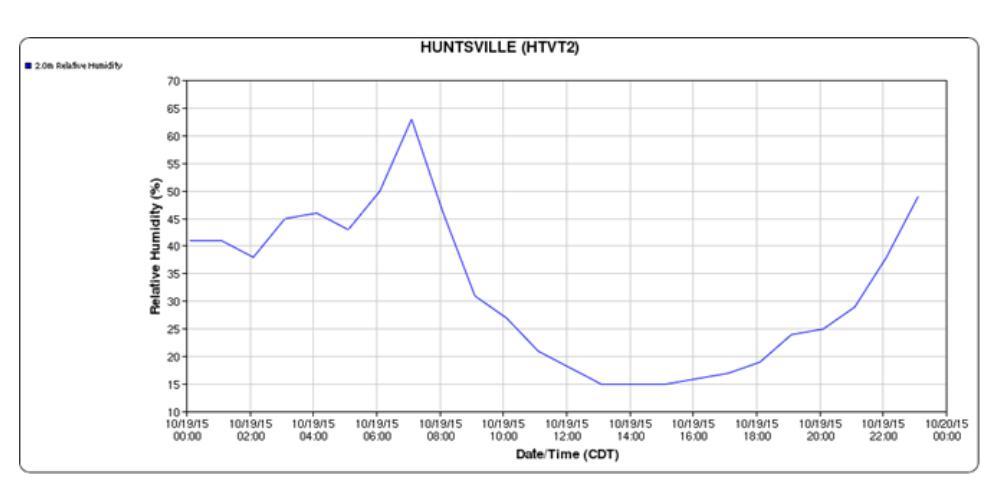
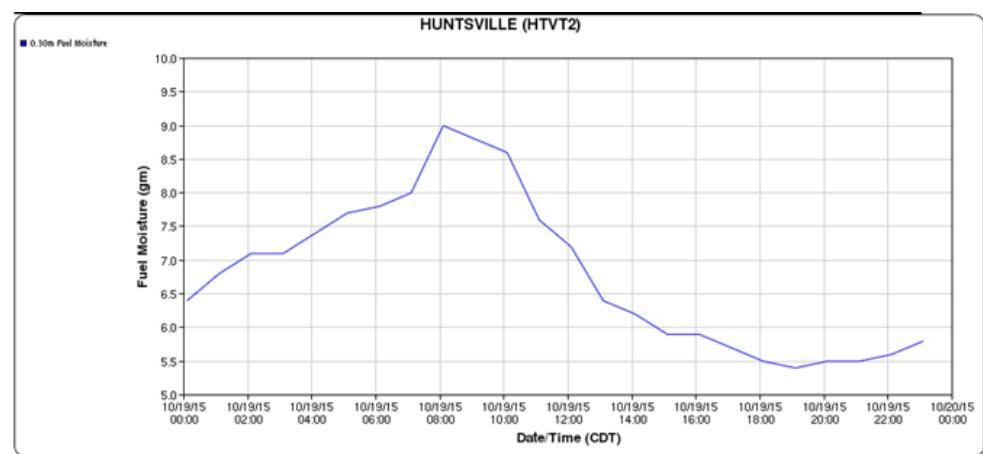
The Huntsville RAWS recorded very poor relative humidity (RH) recoveries the morning of the 19th with an RH of only 63%. During the afternoon, the minimum RH bottomed out 15% from 1300-1500 and slowly recovered into the 20% range in the evening.

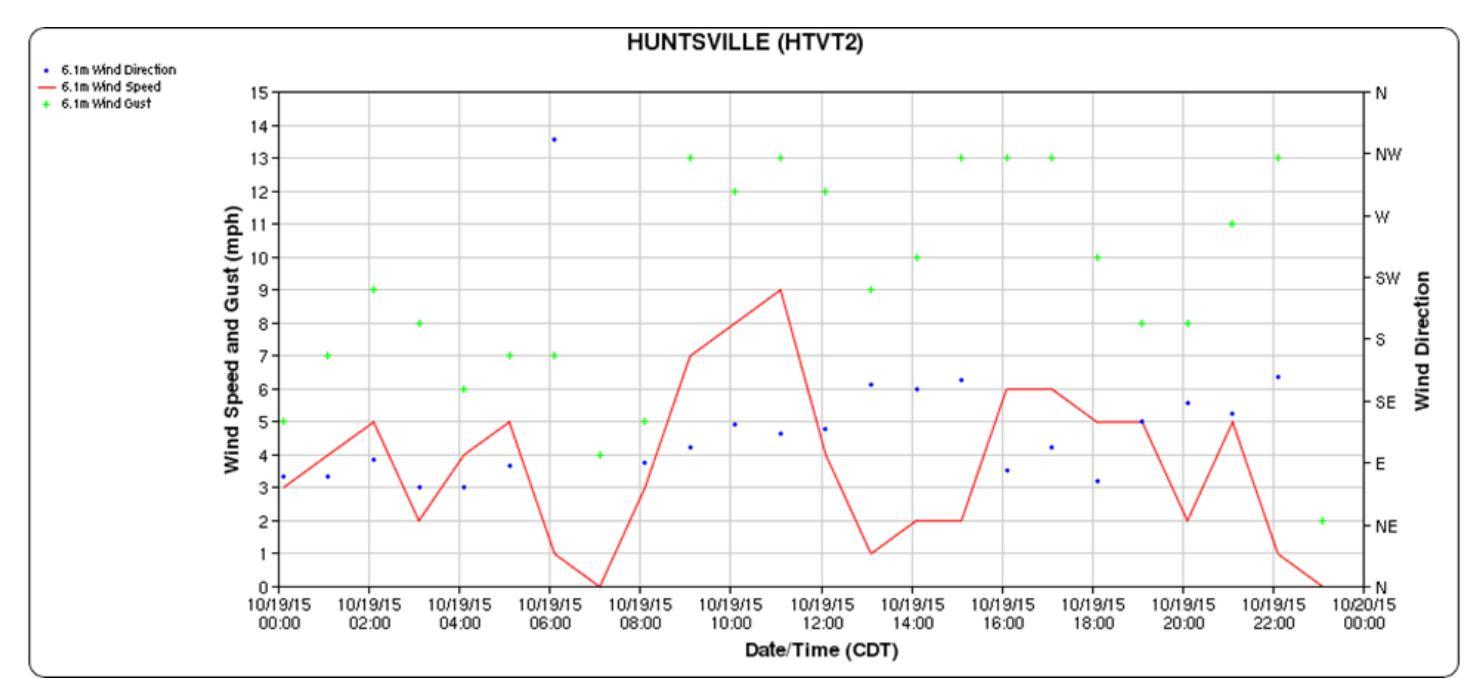
The poor RH recovery the morning of the19th and from several days prior, resulted in very low 10-hour fuel moistures. 10-hour fuel moistures recovered only to 9 grams at 0800 and went down to under 5.5 grams by 1800. Winds at the Huntsville RAWS during the time of active burning of the Northside Fire 1300-1900 ranged from 1-6 mph with gusts of 9-13 mph from the Southeast.

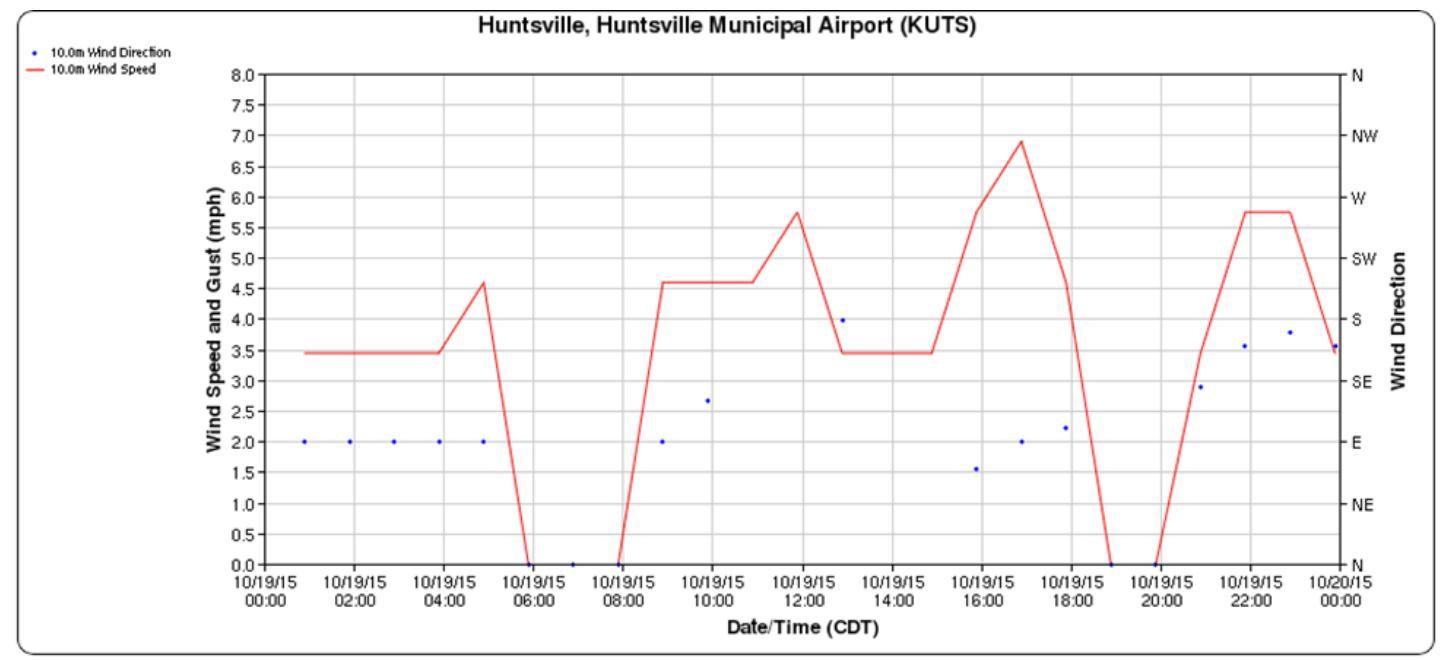
The Huntsville Municipal airport recorded Southeast winds from 3.5-7 mph during the same time. These winds speeds are likely more representative based on the rate of spread and fire behavior for the Northside Fire. Wind gust observations are not recorded at this location so the Huntsville RAWS wind gust data will be used.

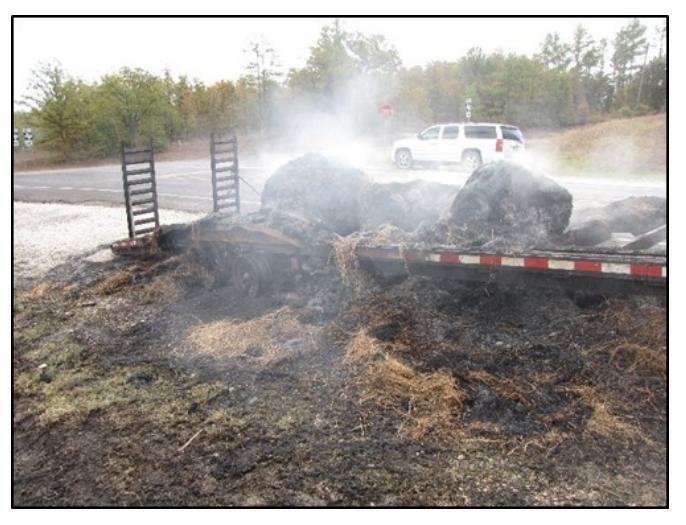
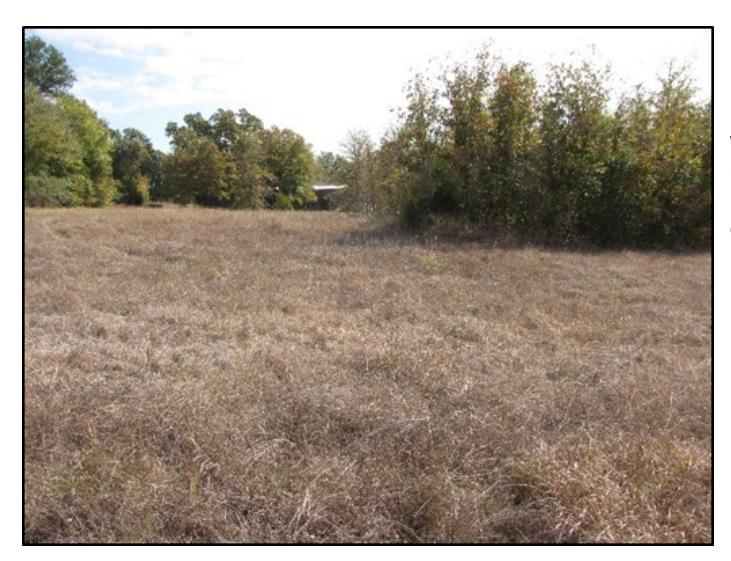
The grasses opposite of where the fire ignited, represents the surface fuels and fine fuel loading that was likely present. There was little greenness present in these grasses. Fine fuel loading was continuous and above normal.

An open canopy environment was present in the fine fuels. Multiple ignitions coupled with winds likely allowed for a large grass fire with a large head that moved rapidly into the post-oak timber surface fuels in the distance.

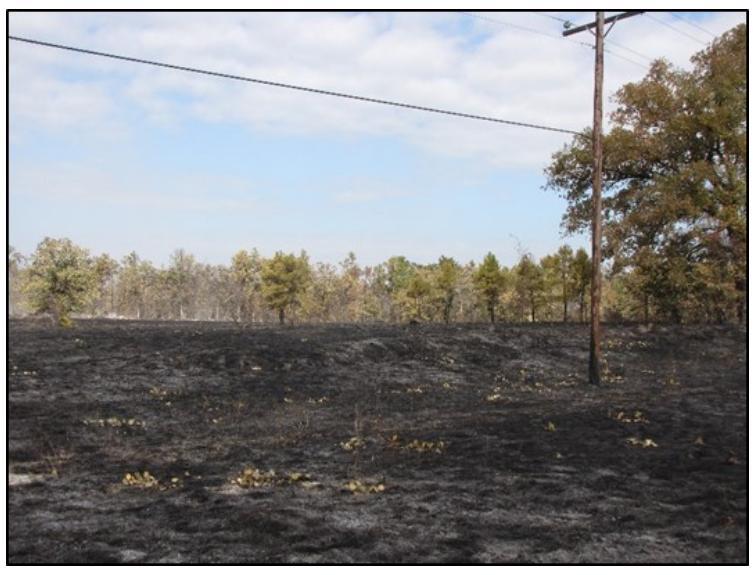
Fire grassy fuels and S/SE winds pushed the fire W/NW throughout a post-oak savannah.

Complete combustion of fine, 1-hour surface fuels occurred here.

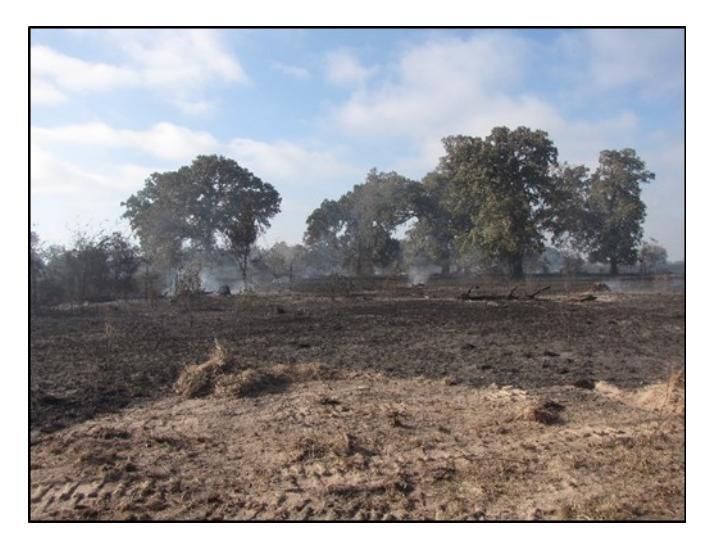
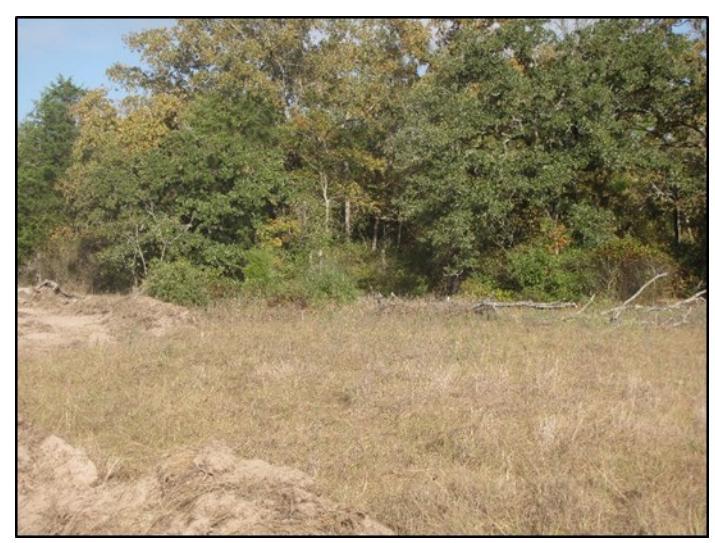
Fine, grassy fuels on the opposite site the containment line represent the surface fuels that allowed the fire to spread. Some greenness is present, but fuels are continuous and can be described at above normal fine fuel loading.

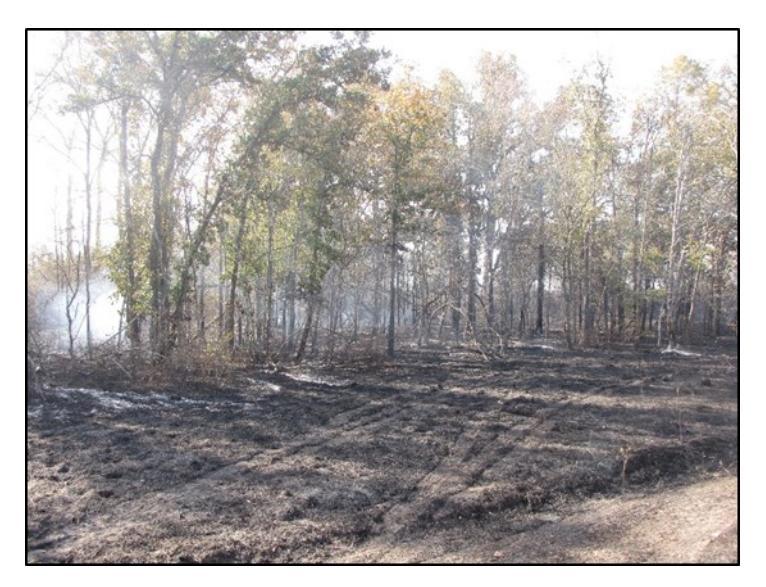
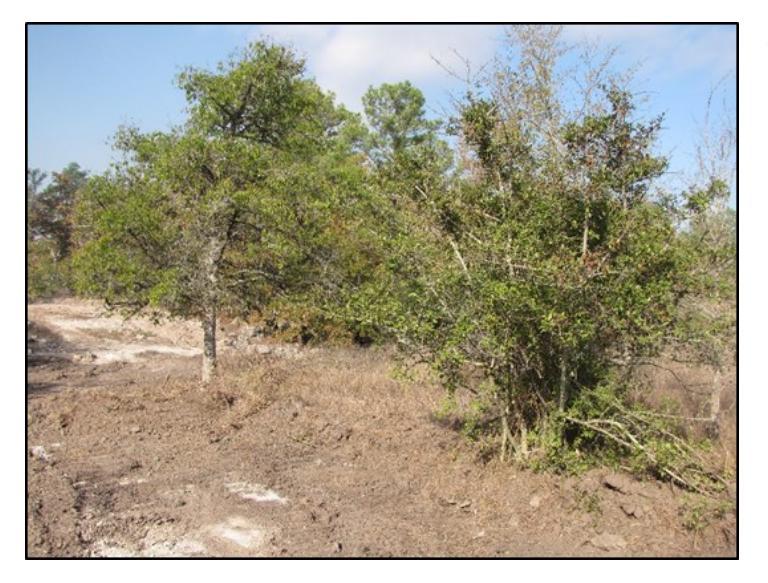
The semi-open canopy environment allowed for sunlight to reach the surface and grasses to grow during the spring. Above normal fine surface fuel loading allowed for the fire to continue through this type of environment.

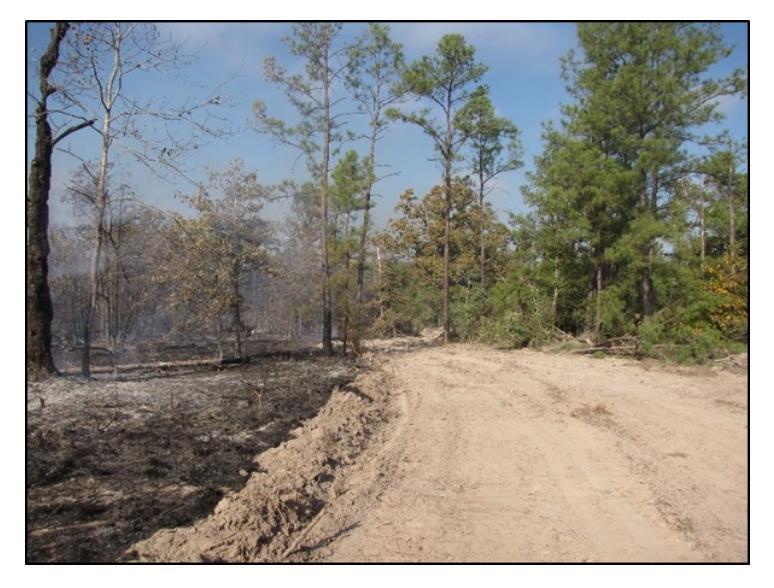
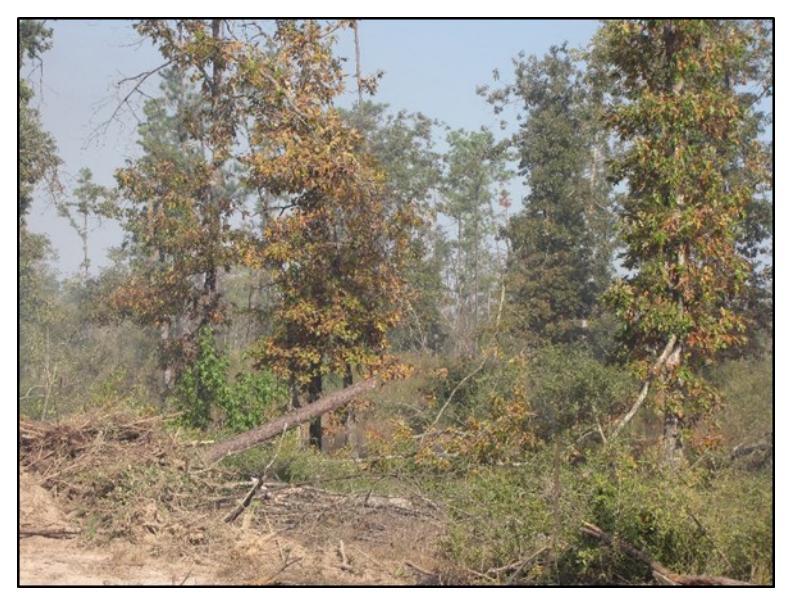
Cutover from past timber harvesting created a mix of open and closed canopy timber fuels. Sunlight reaching the surface provided an opportunity for grass and brush to grow over 100 and 1000 hour fuels on the surface. This mix of herbaceous growth (1-hr and 10-hr fuels) provided enough heat energy for combustion of these large down surface fuels.

The above photo is adjacent to the photo to the right. The surface and understory fuels saw complete combustion. Fire intensities were likely had high flame lengths based on the amount of fuel loading present and complete combustion at the surface. This type of fire behavior would create resistance to control issues for suppression resources.

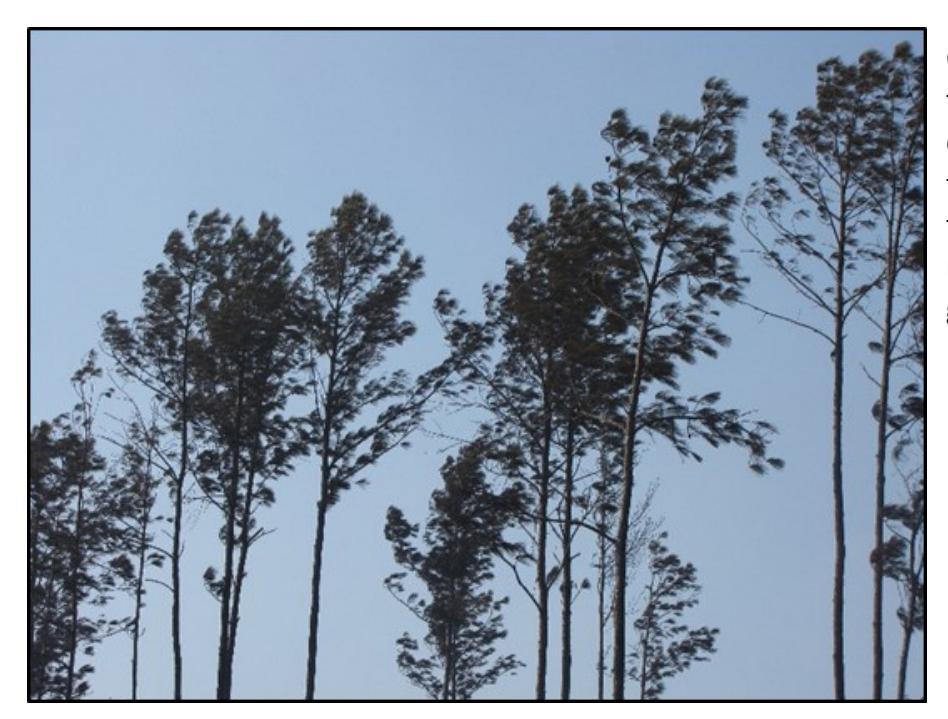
Convection from the high fire intensity froze pine needles in the upper canopy of the pine trees in this photo. The needles are frozen pointing in toward the W/NW indicating the direction the head of the fire progressed.

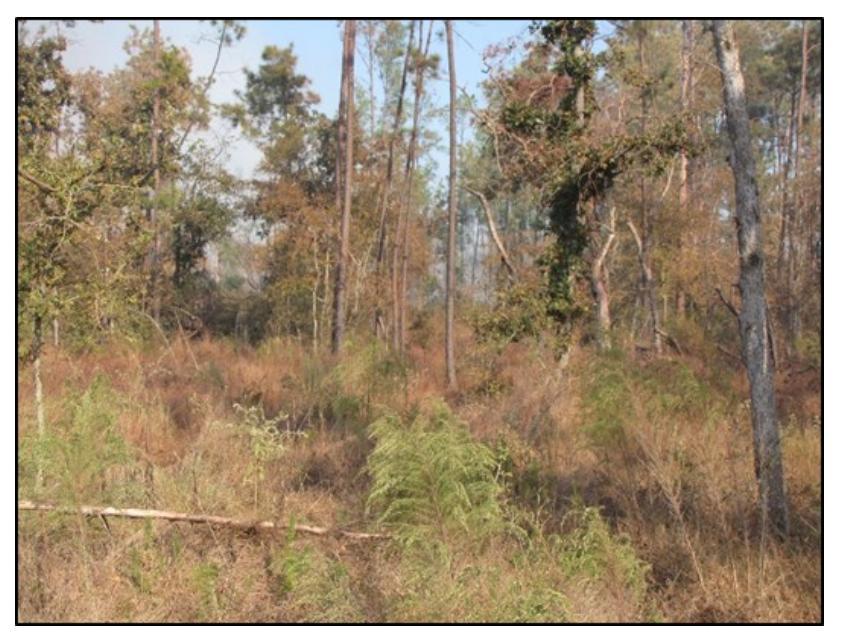
Representation of herbaceous growth in cutover. High fuel load at the surface in this mix of open and closed canopy environment.

Fire only burned at the surface at this location. Ladder fuels were not available and or fire intensity was not as high for fire to cause single tree torching

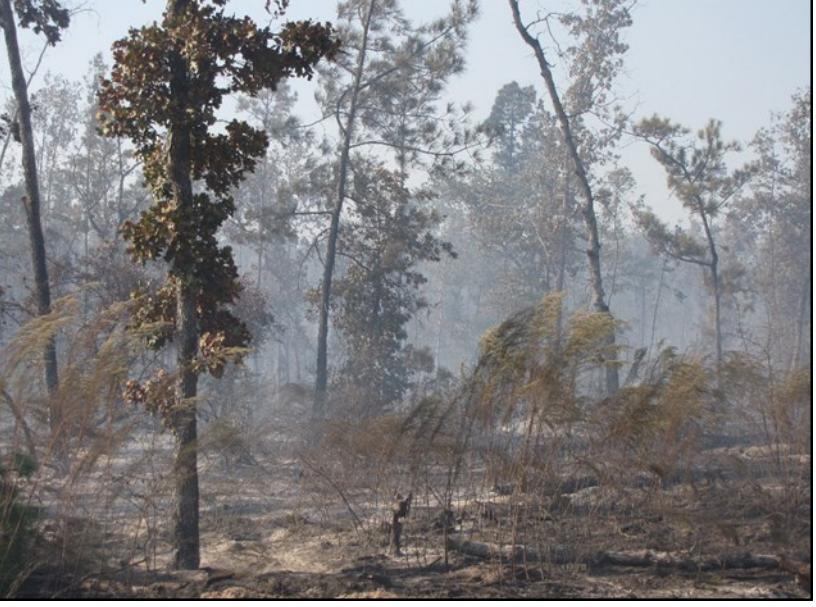
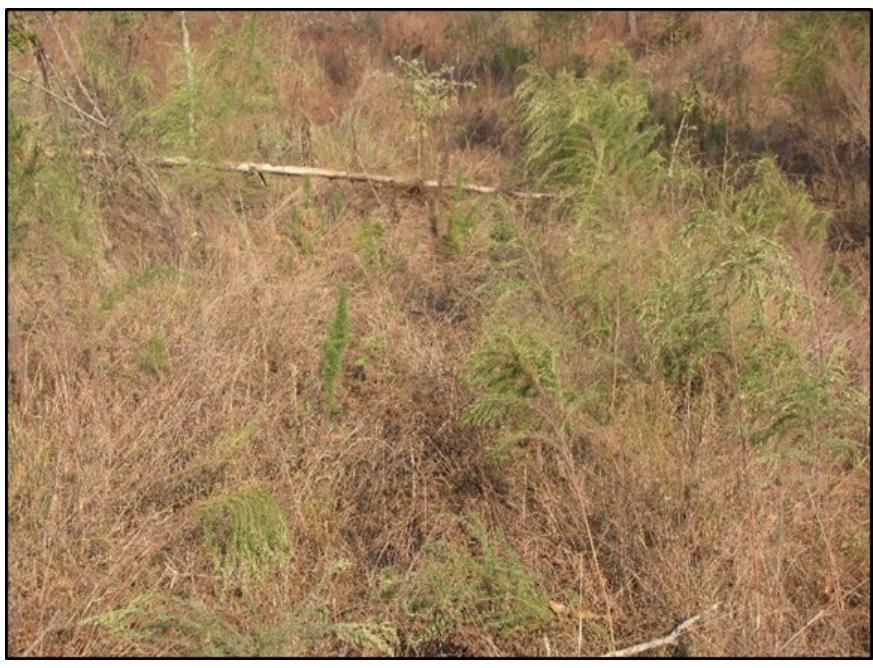
Continuous fine fuel loading from summer cured grasses in the mixed canopy environment provided for high rates of spread.

The grasses do not have much greenness and are laid over indicating high the fine fuel load weight This is an indication of above normal to exceptional fine fuel loading.

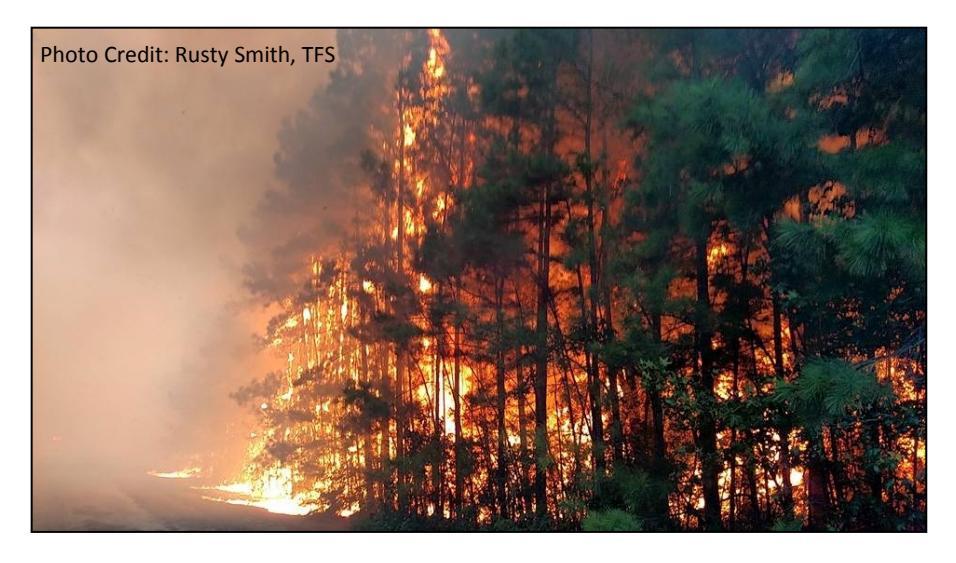
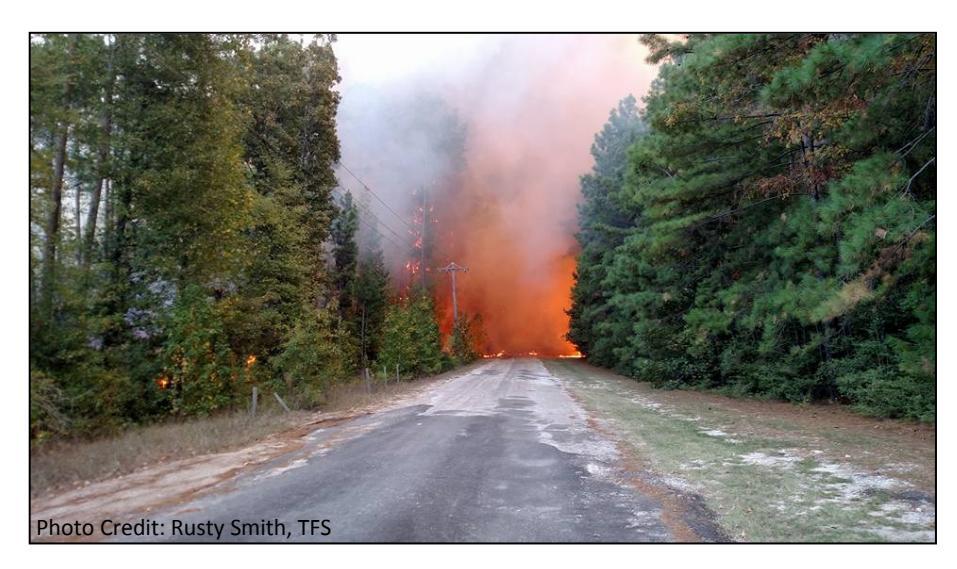
Observed winds were Southeast 6-7 mph with gusts of 13 mph. RH was at 17%. Spotting of 200 feet was observed.

The right of way created by the road way also could funnel wind and create small eddy's that lead to single or group tree torching at the edge.

Near complete consumption of surface and understory pine timber fuels was present.

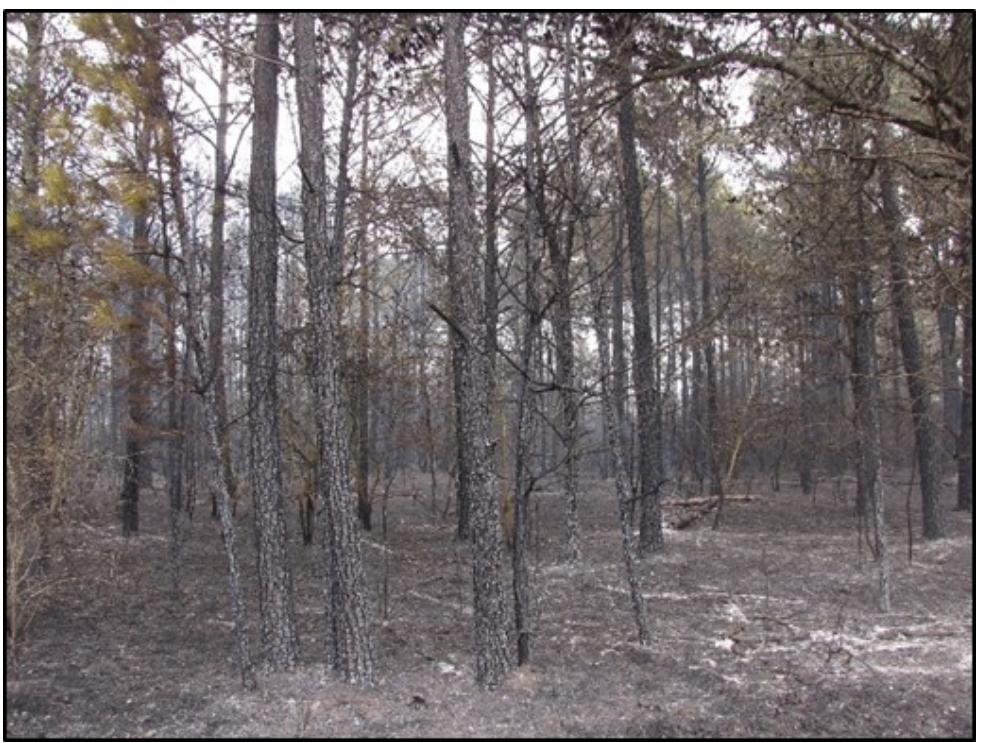
Pine timber and yaupon understory at head of the fire. Fire retardant is visible from drops made my aerial resources.

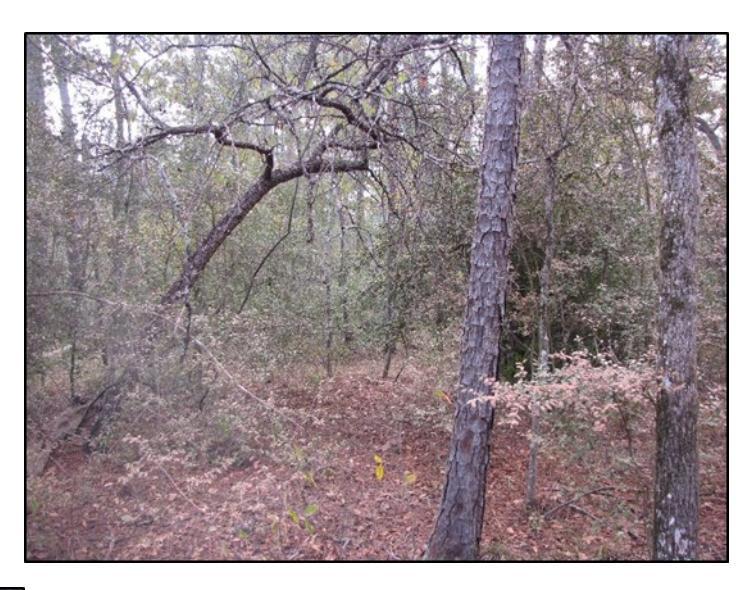
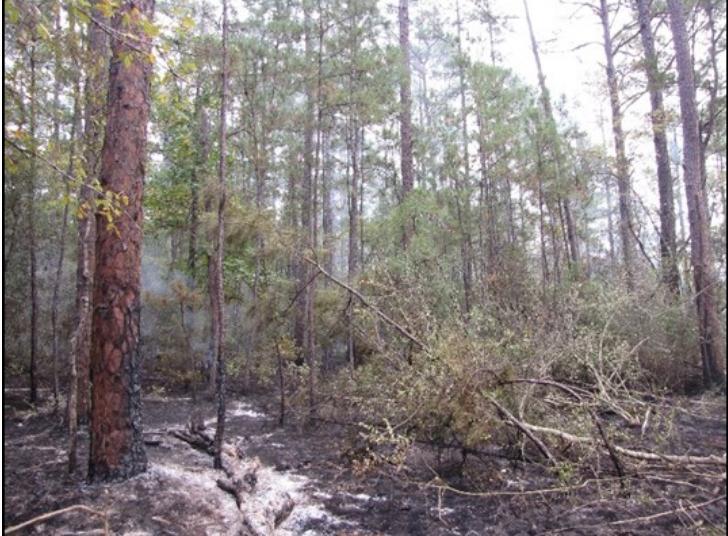
This is located at the end of the forward fire progression. Aerial resources were used heavily with water and retardant drops.

Effective use of drops occured in this high risk fuel of pine timber and yaupon. L. Kanclerz was close by when drops were made.

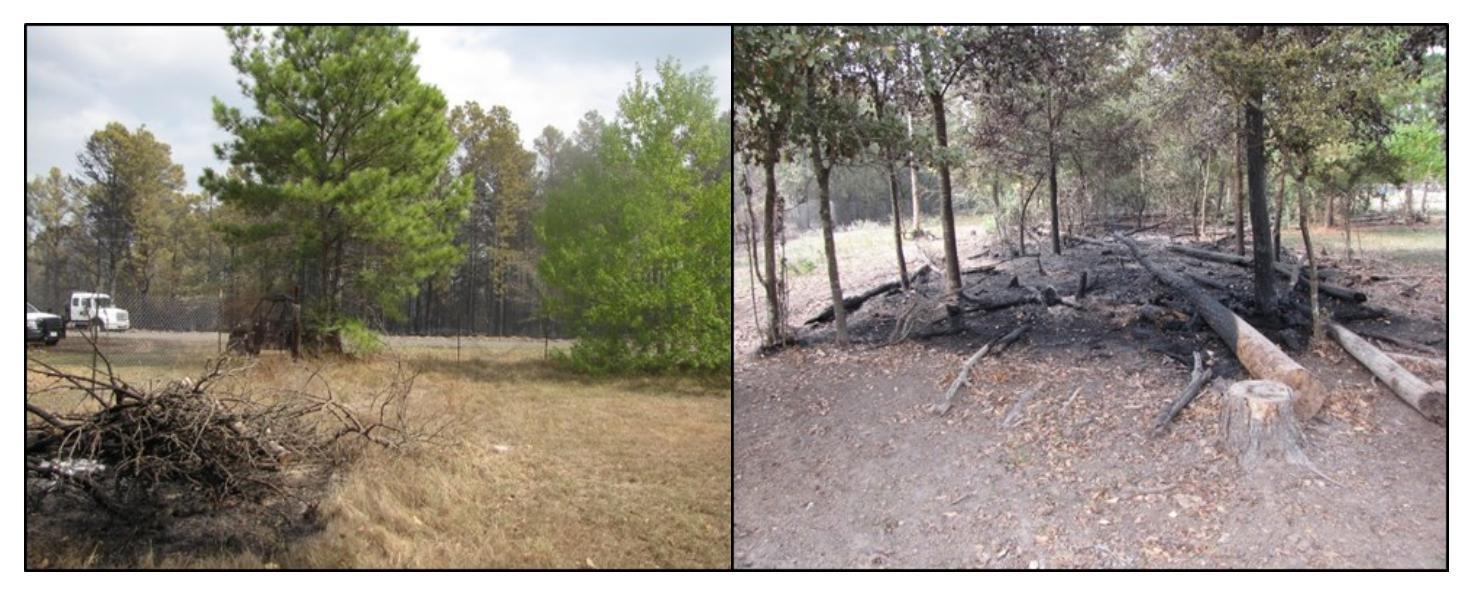
Spotting from fire. Surface fuels of cured grasses (left) and timber litter (right) were receptive to ignition. Spotting distance of approximately 300 feet occurred here.

Fire intensity was high to extreme as complete combustion of surface, understory, and canopy fuels is observed. Canopy fuel are completely consumed. The dozer line was placed after the primary fire activity.

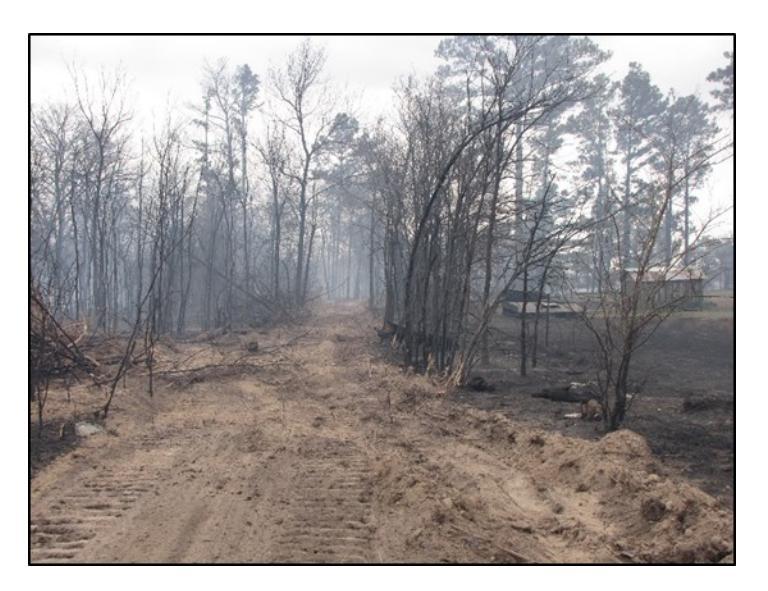
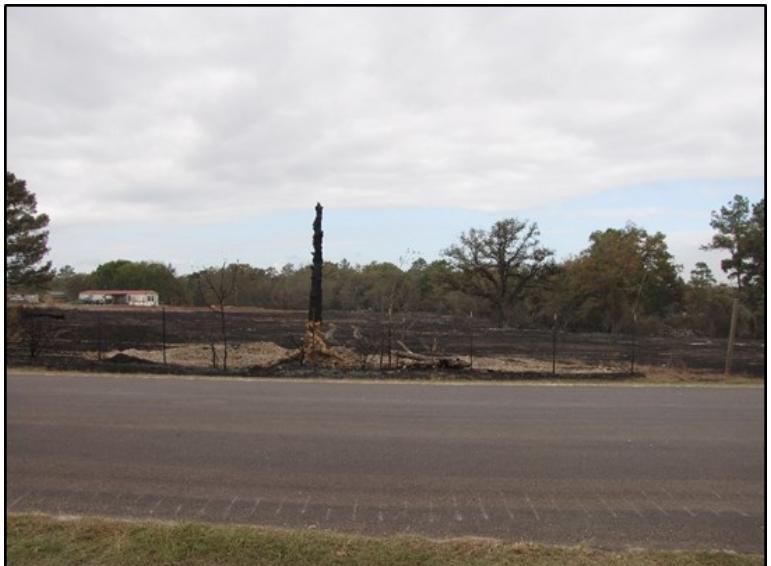
Spotting occurred from the extreme fire behavior. Spotting in pasture land approximately 4 acres on west side of Wallace Rd.

Spotting distances of 300+ feet observed

Large head fire exhibiting extreme fire behavior moving west toward Wallace Rd. Torching is visible at the edge of the timber fuels. Fire departments providing structure protection. Photo at approximately 1615.

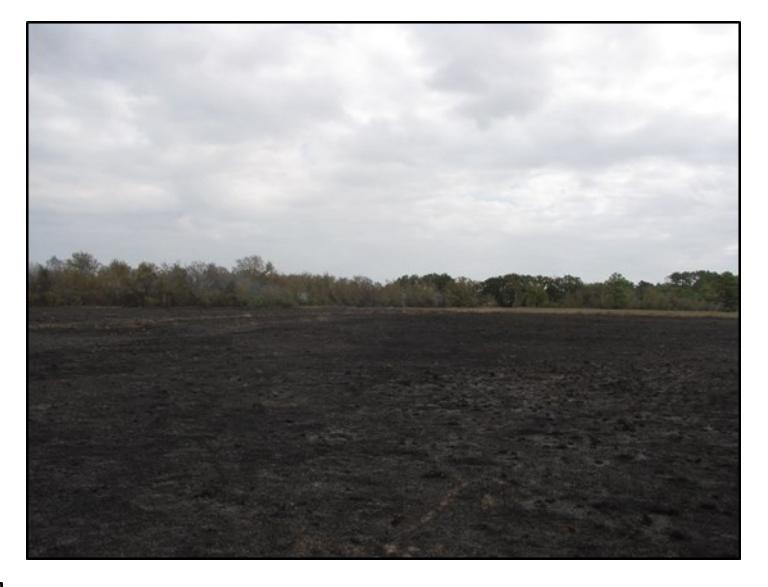
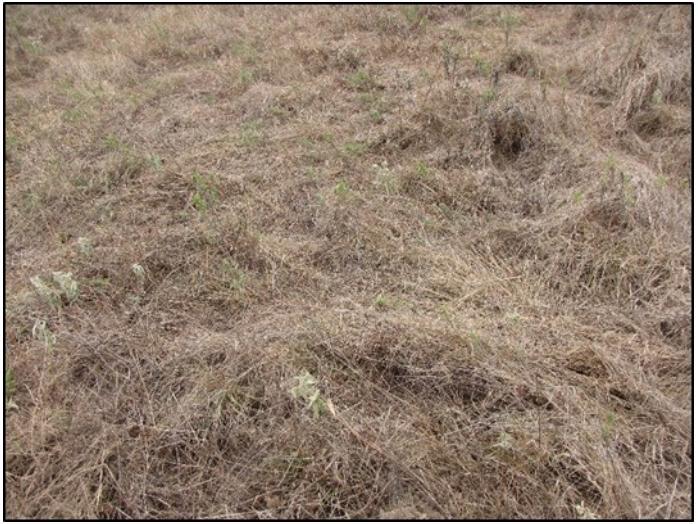
Continuous fine fuel loading of grass surface fuels consistent around the fire. Little greenness and above normal/exceptional fine fuel loading

Timber litter fuels carried the fire at the surface in this high risk fuel of pine with yaupon understory. Winds were S/SE so the fire likely backed at the surface with lower flame lenghts to the containment line.

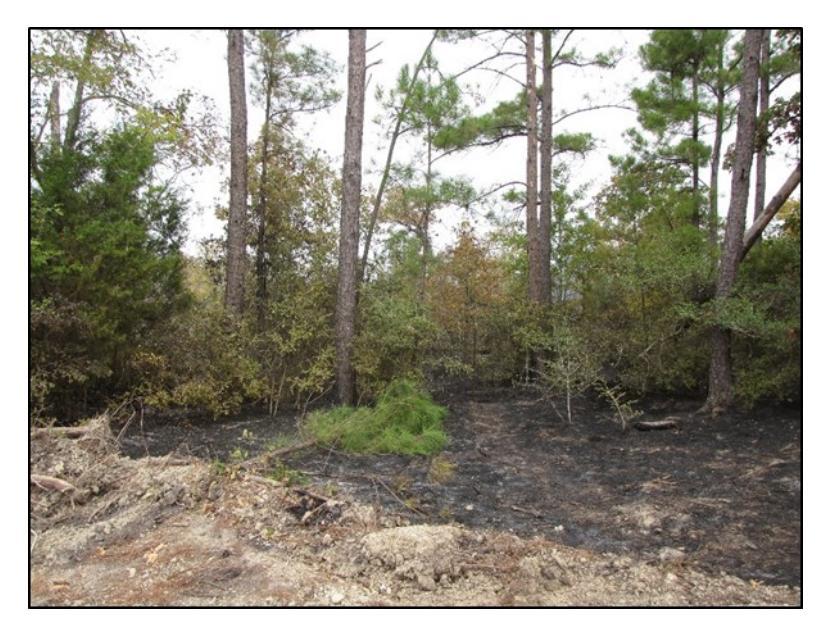
Closed canopy pine stand with near complete understory and surface fuel consumption. Scorch marks on trees indicate fire intensity and flame length although there is little to no tree torching present.

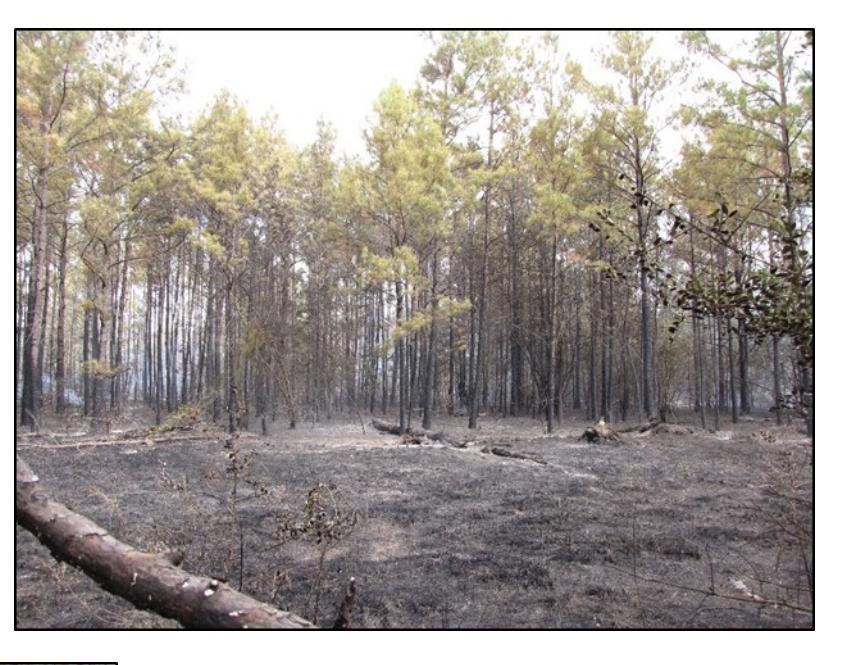
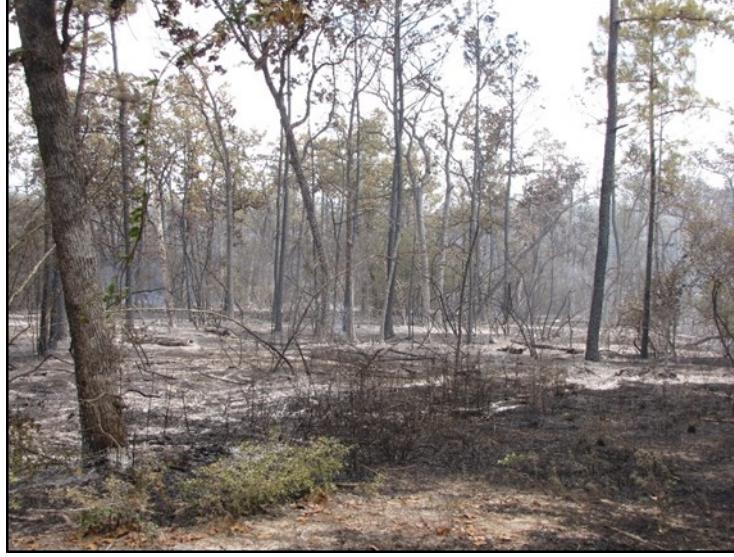
Moving east toward the heel of the fire, the transition back to the post-oak dominated landscape is observed.

Fire intensities were likely moderate to high with due to the open canopy with herbaceous grasses mixed with some timber litter. Isolated single tree torching occurred here. Smaller trees and shrubs are completely consumed.
