5 Mile Dozer Tip-Over

Lessons Shared

On Tuesday, August 18, 2020, Texas A&M Forest Service (TFS) employees traveled to the 5 Mile GLO in northern Liberty County, Texas to perform site preparation operations for tree planting, using a CAT D7 dozer. When the dozer was being unloaded at the site, it shifted on the trailer and then slid off, resulting in the dozer tipping over onto its side on the ground next to the transport.

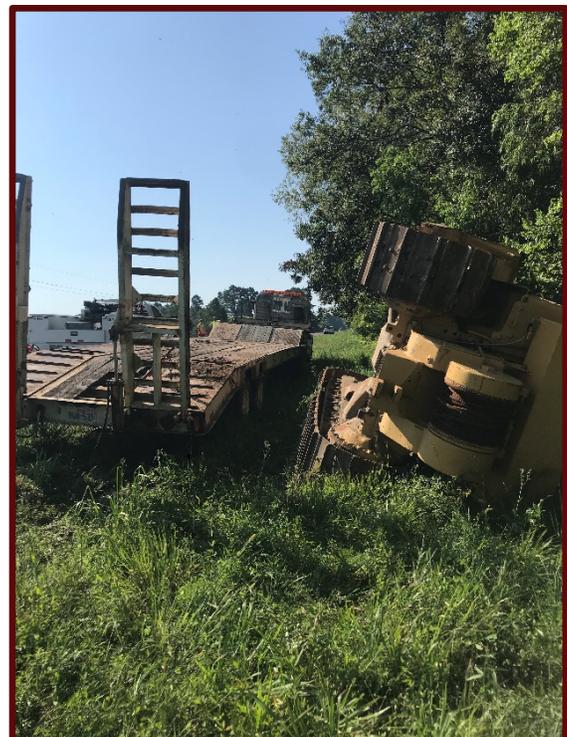
Figure 1: Dozer and transport after operator exited and ramps were raised.

putting it in gear and slowly creeping backward. As the dozer crept backward on the trailer, the operator looked down and noticed the dozer had shifted, and the right track was slightly hanging off of the edge of the trailer. At that time, the operator stopped, took the dozer out of gear, engaged the parking brake, and got down to assess the situation. At that time, the mechanic had arrived and was able to help with the decision making. They decided that it wouldn't be feasible to try to drive the dozer forward to reposition it on the trailer because the tracks were hanging off too much, and it would likely slide more if they attempted that. At that point, they determined the best option was for the operator to continue to back off of the trailer and try to come down the ramps.

The operator climbed back into the dozer and began slowly creeping backward again. Before the dozer reached the ramps, it slid further off the edge of the trailer, and then the dozer began to tip. It happened slowly, so the operator had time to turn 90 degrees in the seat and place his feet up against the side of the cage, in the direction of the fall. As the dozer tipped over and landed on its side, the operator was then on his feet inside the cab and was able to shut off the dozer and climb out without any trouble. The operator had time to react, and all personnel on the ground were standing well away from the trailer, so nobody suffered any injuries.

Everyone involved recognized that the tractor-trailer was parked on a slight grade, but none thought it was steep enough to cause any issues. Some noted that they had unloaded a CAT D5 off of a bobtail transport on that amount of slope before, or steeper, with no issues. During the site visit, the FLA team measured the slope at the location to be approximately 12%. This shows that it does not take much of a slope to cause a dozer to slide during unloading or loading.

It was also noted that the slope caused the air bags on the downhill side of the trailer to deflate, resulting in the trailer tilting slightly more than the slope of the ground. How does your hauling equipment react to being on a slope?

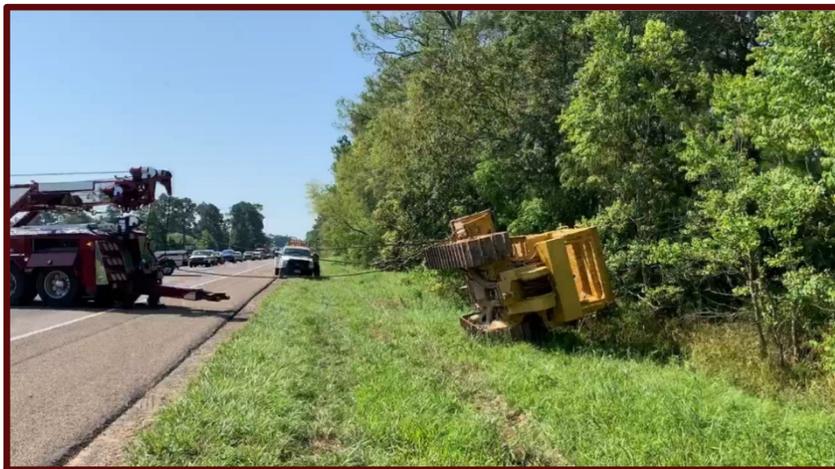
Figure 2: Wrecker with winch attached to dozer, pulling it over onto its tracks.

personnel on the ground to take photos and document the events. After some discussion with everyone on site, including the fire department personnel, and given the close proximity to a busy roadway, it was decided to call for a heavy wrecker to come and pull the dozer back onto its tracks. The wrecker arrived quickly, and the local fire department was utilized to help with traffic control while the wrecker parked in the roadway, hooked to the dozer with a winch, and pulled the dozer over. Afterward, any spilled fuel or hydraulic fluids were properly cleaned up so there was no soil contamination.

The mechanic had the dozer sit for about 15-20 minutes to allow fluids to settle, and then he started it. It started with no problems, and they tracked the dozer on to the 5 Mile GLO to park it there. The tractor-trailer was driven back to the fire station down the road and parked.
